# Comparison of Laboratory Testing Methods for Bridge Coatings

Publication No. FHWA-RD-94-112

June 1995

This report presents correlations among various laboratory accelerated testings and natural outdoor marine exposure of low volatile organic compound (VOC) coating systems for steel bridges. This report represents the findings from these testings that compared low VOC coating systems for steel bridges.

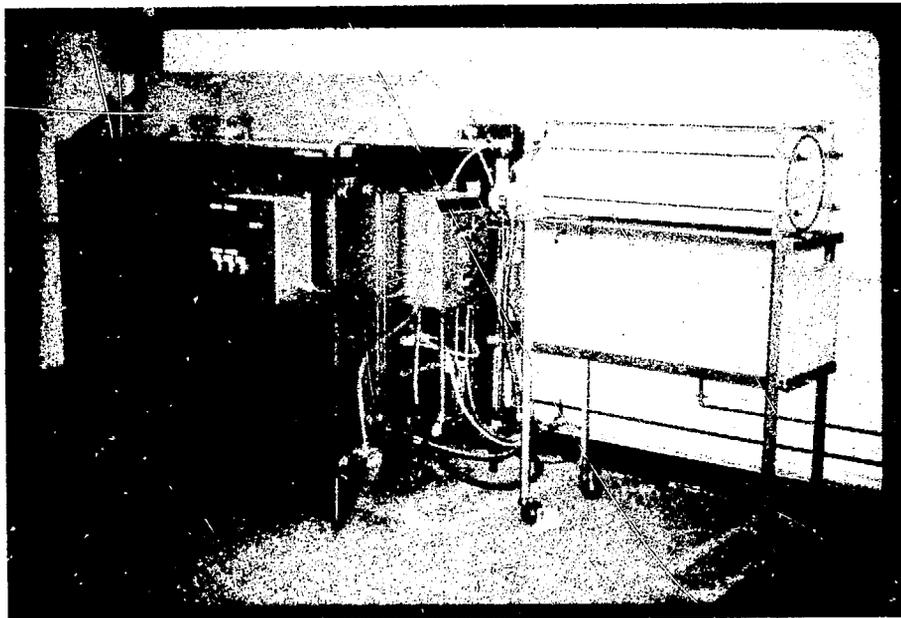
Cover Photo: Prohesion test chamber.

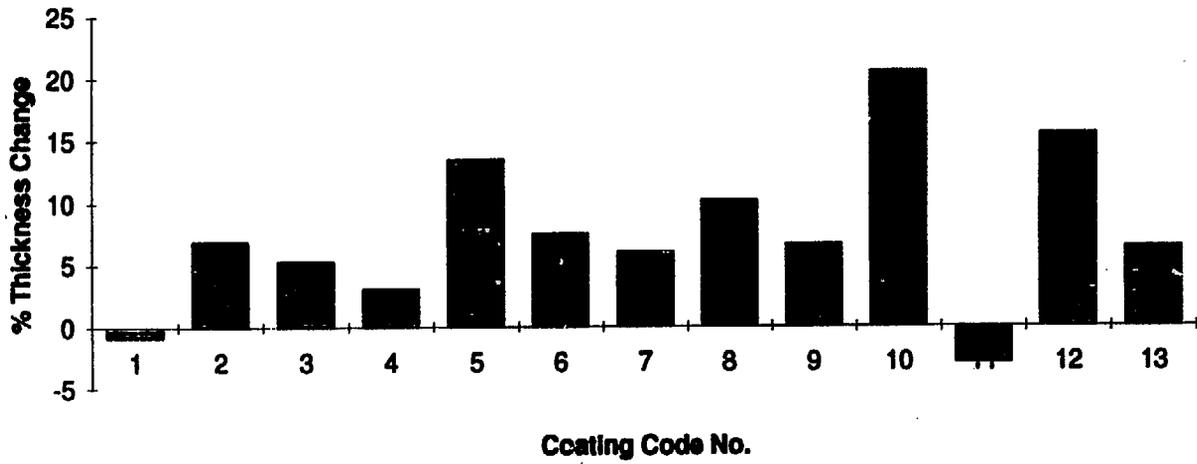
Figure 1. Film thickness change after salt-fog exposure.

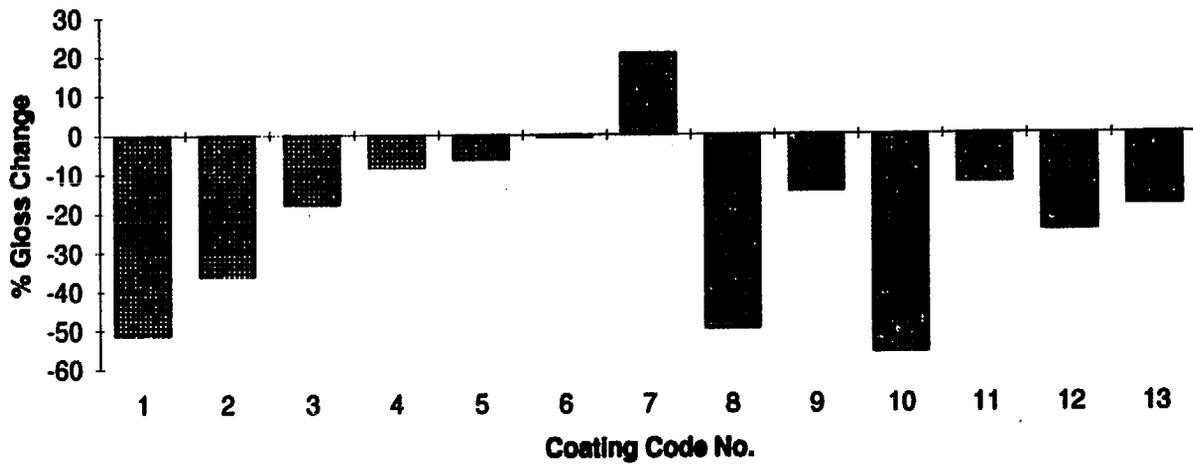
Figure 2. Gloss change after salt-fog exposure.

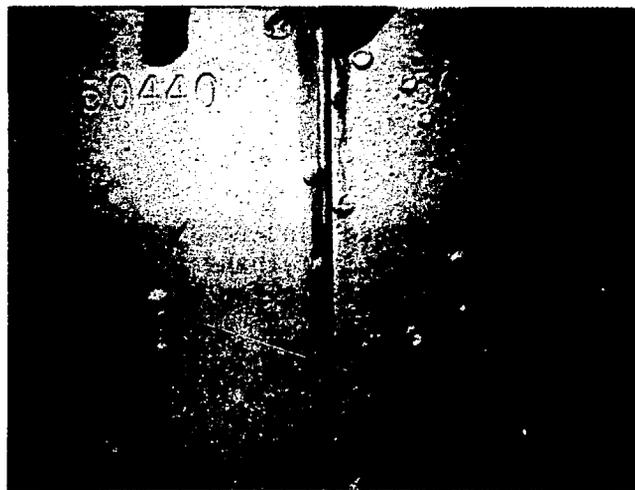
**Figure 3. Condition of the water-based inorganic zinc potassium silicate/acrylic/acrylic system after 500 h of salt-fog exposure.**

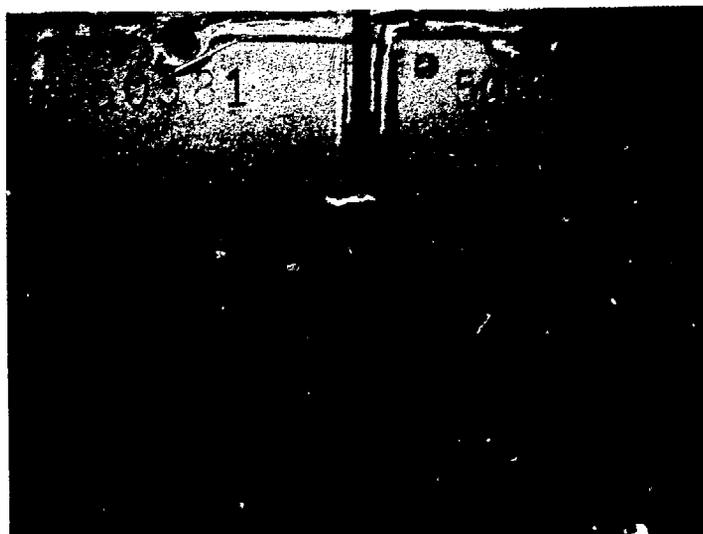
Figure 11. Condition of the waterborne acrylic system after 1,000 h of salt-fog exposure.

All of the coating systems developed creepage or cutback at the scribes. A majority of the coatings undercut to the same degrees of creepages, except for the solvent-based zinc-rich polyurethane/waterborne polyurethane/waterborne polyurethane (VOC of topcoat = 24 g/L, code no. 7) and the water-based zinc-rich epoxy/acrylic/acrylic (code no. 13), which had minute undercutting. No underfilm corrosion was found beneath the blisters at the scribe for these materials, illustrating the cathodic protection of steel afforded by zinc-metal primer. The waterborne acrylic system (code no. 3) exhibited severe blistering at the scribe with a creepage larger than 6.35 mm after 1,000 h of the salt-fog test (figure 11); this rapid failure makes its use in a high-salt environment questionable.

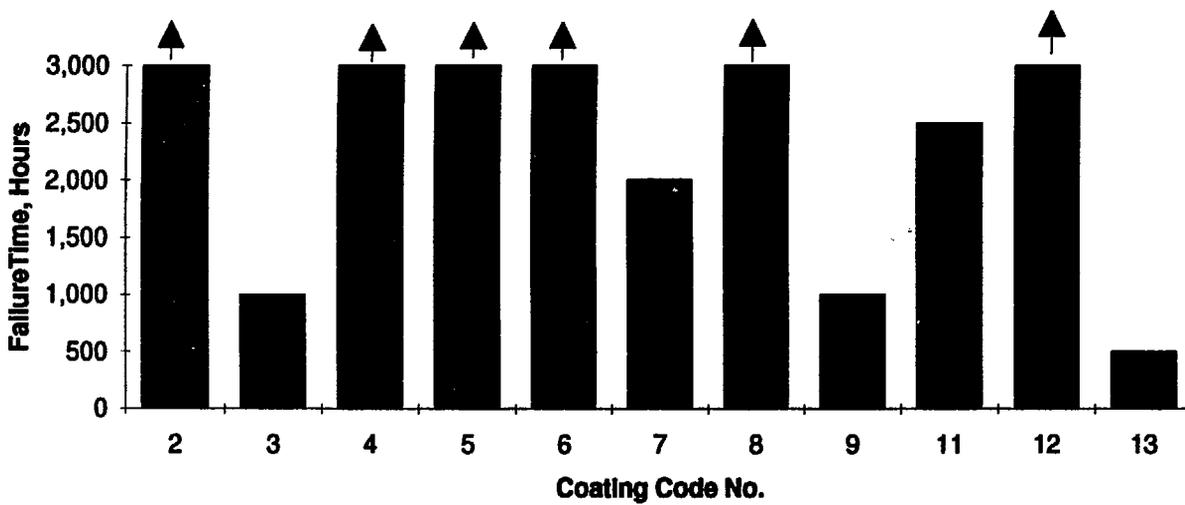
Figure 12. Failure time of the coating systems for developing 6.35 mm of creepage after salt-fog exposure.

To compare coating performance, the failure times yielding more than 6.35 mm (0.25 in) of creepage at the scribes are plotted for all the coatings in figure 12; the arrow symbol (†) denotes time longer than 3,000 h. (Note: code nos. 1 and 10 are not included.) If a creepage of 6.35 mm or greater is used as a criterion for failure, the high-solids epoxy (code no. 2), waterborne acrylic epoxy (code no. 4), two solvent-based zinc-rich polyurethane/polyurethane/polyurethane (code nos. 5 and 6), epoxy mastic/polyurethane (code no. 8), and waterborne vinyl systems (code no. 12) did not fail at the scribe after 3,000 h of the salt-fog test. Other coating systems performed as follows (in decreasing order): low-VOC epoxy/acrylic modified epoxy (code no. 11), solvent-based zinc-rich polyurethane/waterborne polyurethane/waterborne polyurethane (code no. 7), epoxy urethane mastic/polyurethane (code no. 9), waterborne acrylic (code no. 3), and water-based zinc-rich epoxy/acrylic/acrylic (code no. 13).

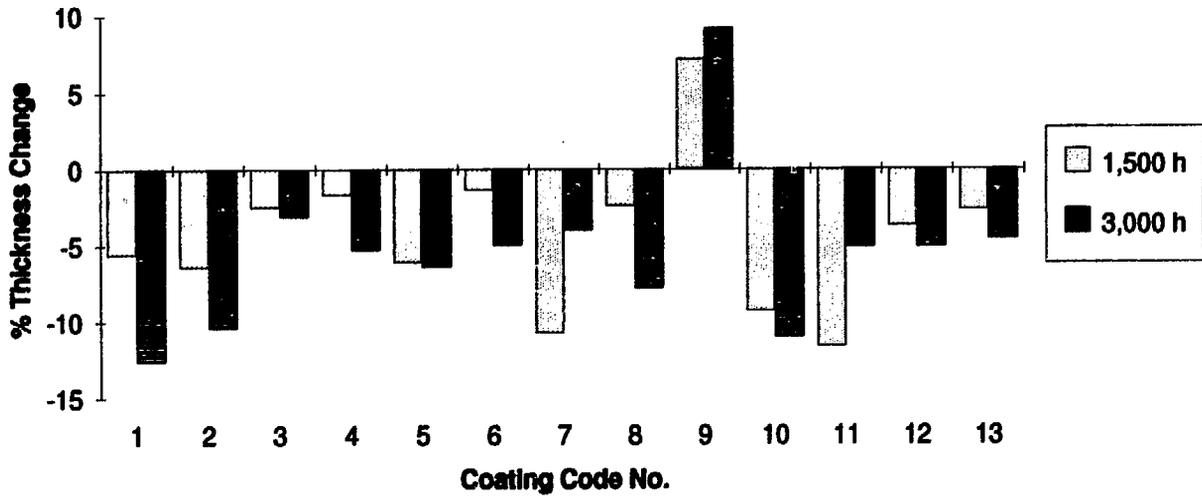
Figure 13. Film thickness change of the coating systems after 1,500 and 3,000 h of Prohesion exposure.

The changes of coating film thickness and gloss after 1,500 and 3,000 h of the Prohesion test are plotted in figures 13 and 14 respectively. All the coating systems lost some film thickness, except the epoxy urethane mastic/polyurethane (code no. 9) which must have absorbed water during the exposure period. With the exception of a gloss increase for the waterborne polyurethane (code no. 7), all the coating systems suffered gloss reduction after 3,000 h of the Prohesion exposure.

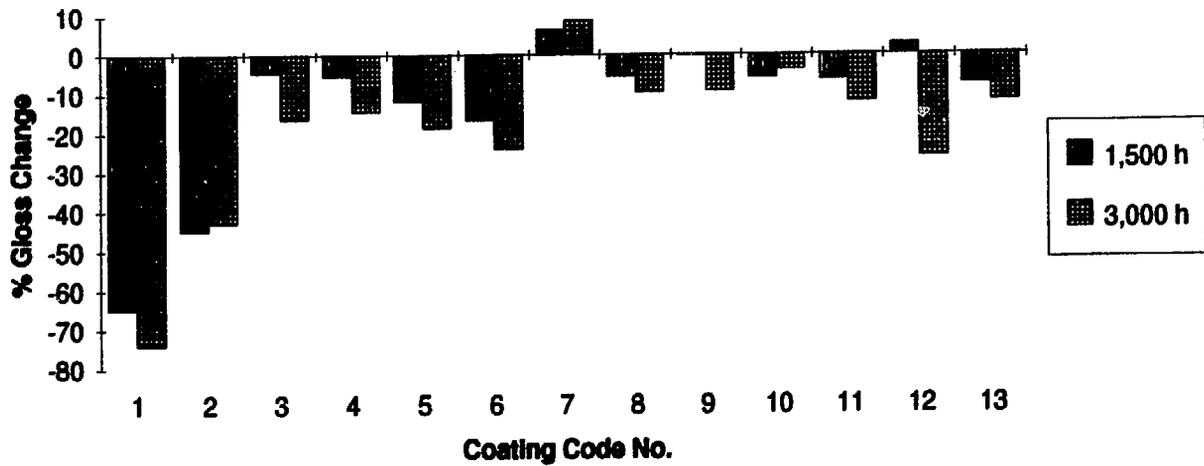
Figure 14. Gloss change of the coating systems after 1,500 and 3,000 h of Prohesion exposure.

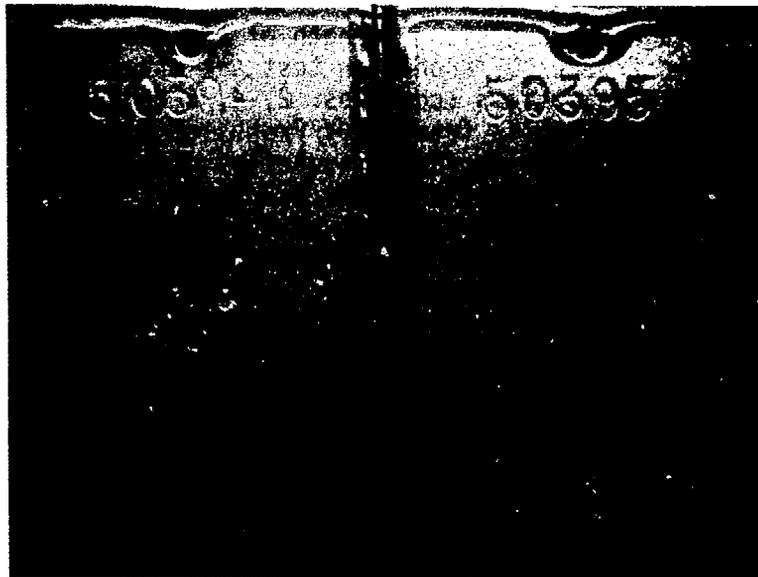
Figure 16. Condition of the waterborne acrylic epoxy system after 3,000 h of Prohesion exposure.

and 336 g/L, respectively). Among all the coating systems tested, the waterborne acrylic epoxy system failed most rapidly. It developed 8.5 mm of creepage (>6.35 mm) at the scribe after only 1,000 h of the Prohesion test as demonstrated by figure 16; on the contrary, this system showed a creepage of only 6.0 mm after 3,000 h of the salt-fog test. This difference in failure results implies that the waterborne acrylic epoxy may be prone to the attack of the weak acid (ammonium sulfate) used in the Prohesion test.

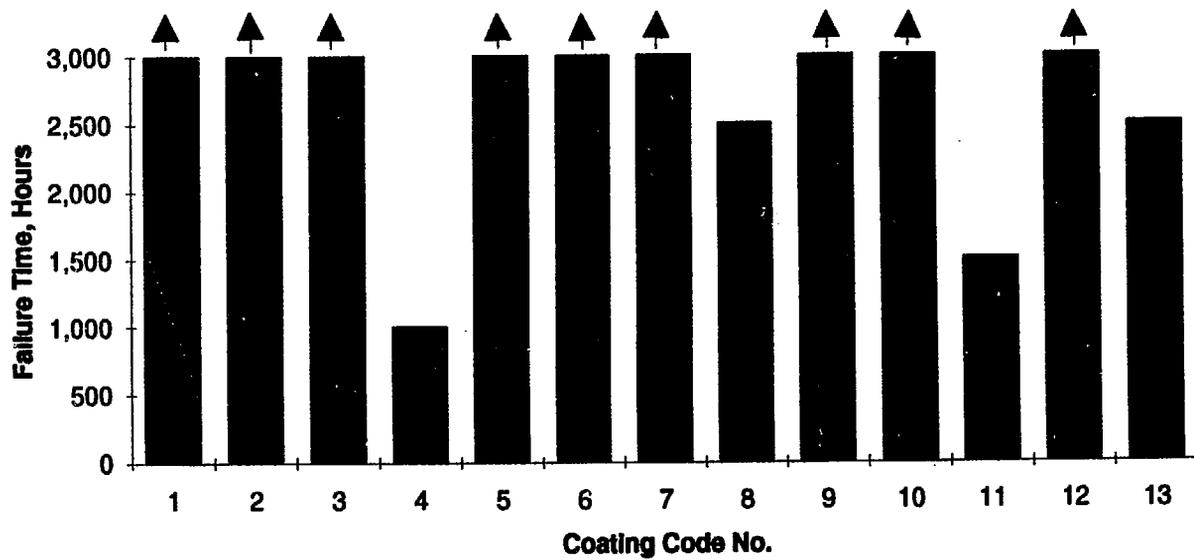
Figure 17. Failure time of the coating systems for developing 6.35 mm of creepage after 3,000 h of Prohesion exposure.

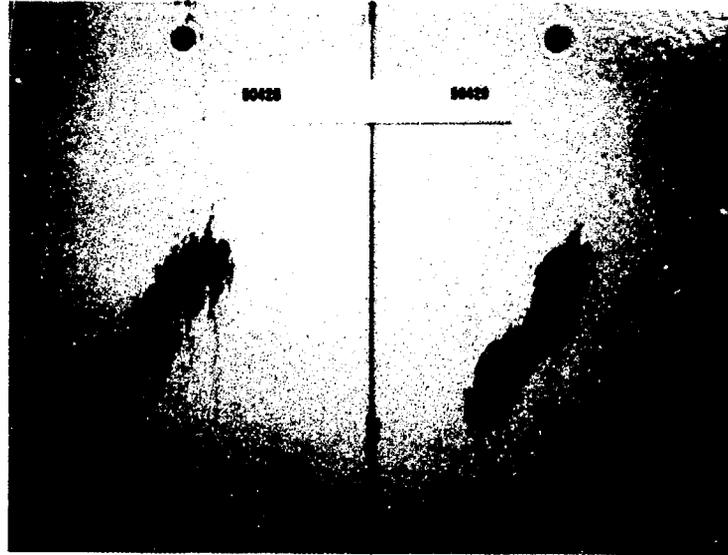
Figure 18. Condition of epoxy mastic/polyurethane system after 3,000 h of Prohesion exposure.

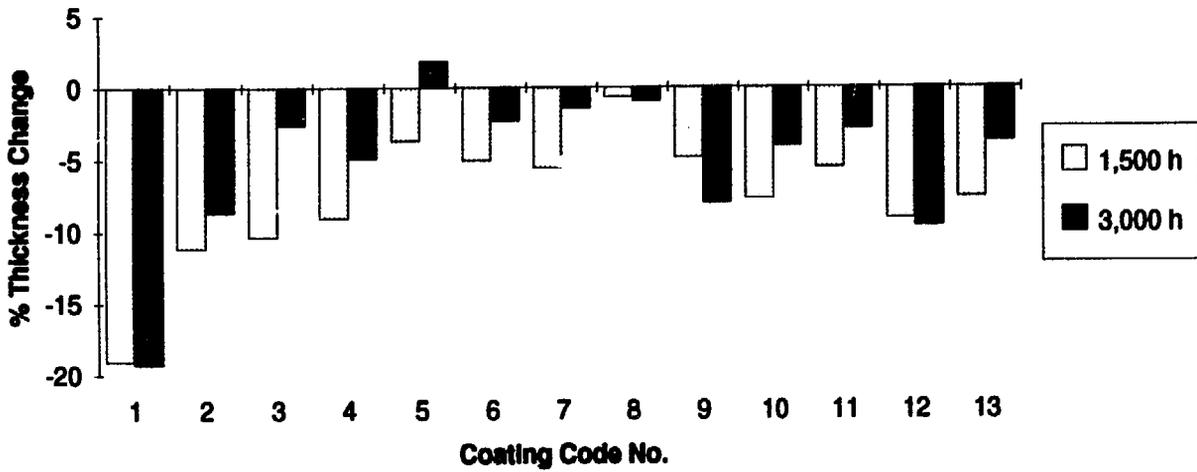
Figure 21. Film thickness change of the coating systems after 1,500 and 3,000 h of cyclic freeze/QUV/Prohesion exposure.

The changes in the film thickness and gloss after 3,000 h of the cyclic freeze/QUV/Prohesion testing are shown in figures 21 and 22, respectively. The film thickness of all the coating systems were reduced by the exposure; the small increase detected for code no. 5 after 3,000 h may not be significant. The gloss of all the coating systems declined after exposure, except the solvent-based zinc-rich polyurethane/waterborne polyurethane/waterborne polyurethane system (code no. 7), which increased in gloss. A similar increase for the system was noted after the salt-fog exposure and the Prohesion exposure.

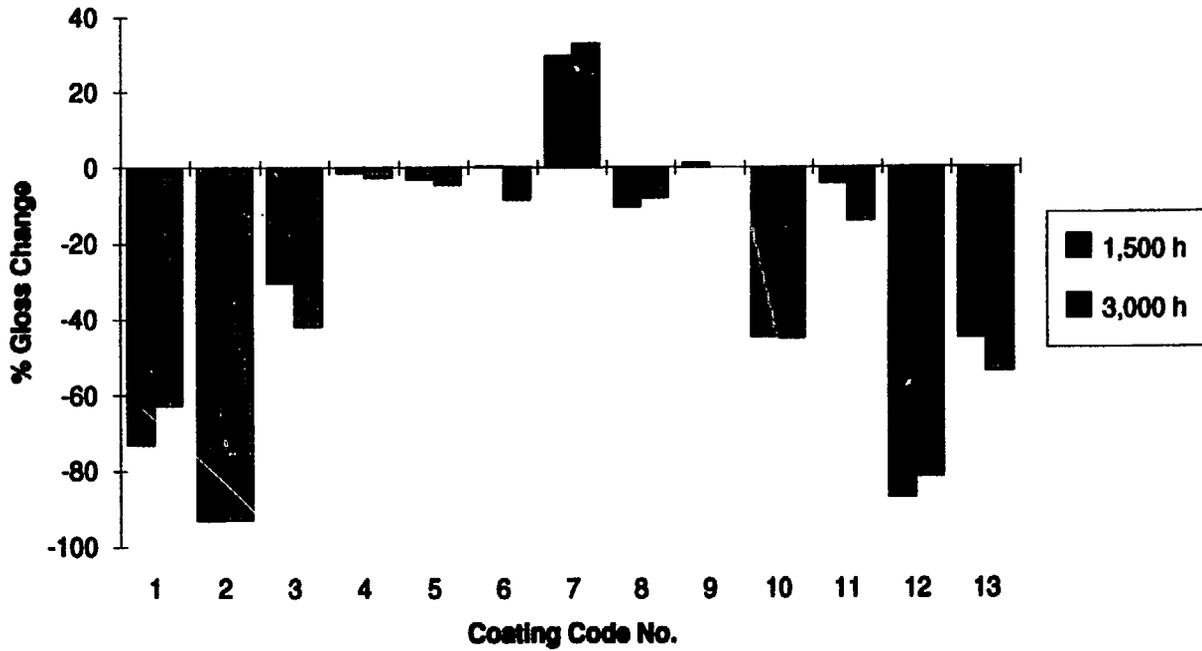
Figure 22. Gloss change of the coating systems after 1,500 and 3,000 h of cyclic freeze/QUV/Prohesion exposure.

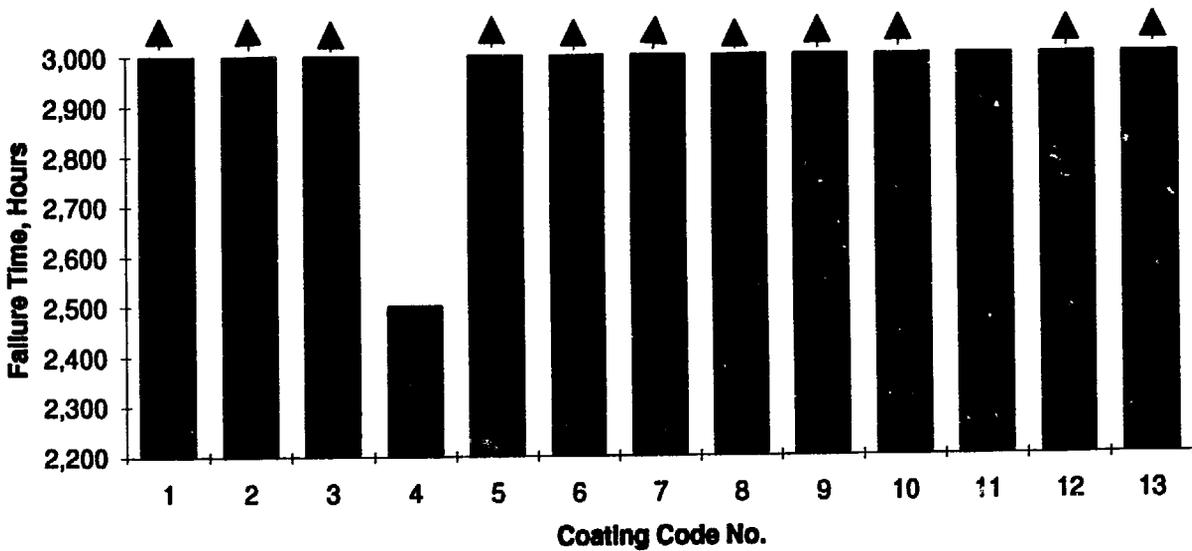
Figure 29. Failure time of the coating systems for developing 6.35 mm of creepage after cyclic freeze/QUV/Prohesion exposure.

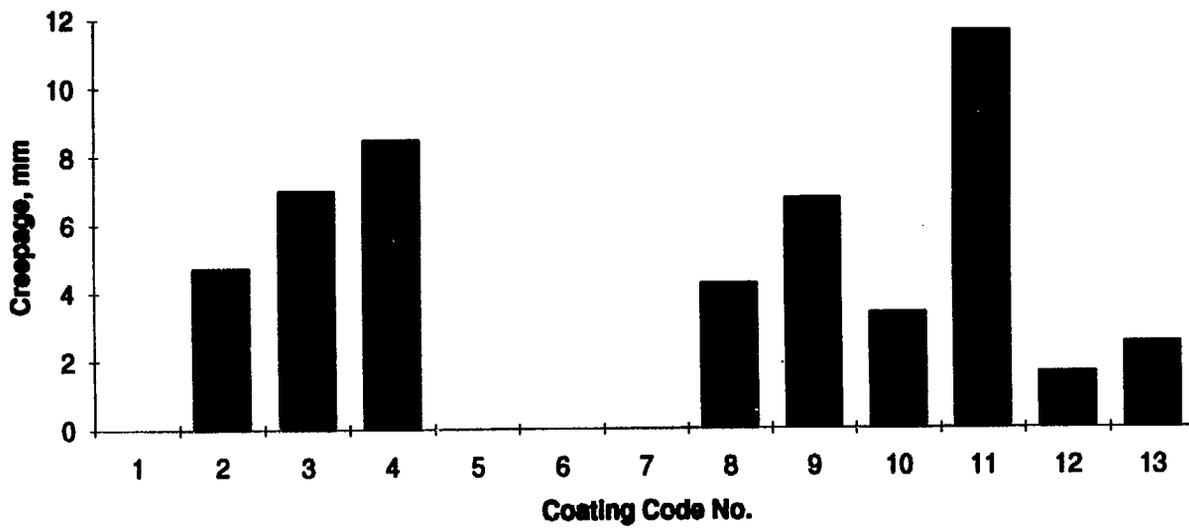
Figure 31. Creepage of the coating systems after 28-month outdoor marine exposure at Sea Isle, New Jersey.

The scribe creepage in millimeters for all the coating systems are plotted in figure 31. The low-VOC epoxy/acrylic modified epoxy showed the largest amount of scribe creepage (8.2 mm, figure 32). The waterborne acrylic and acrylic epoxy coating systems developed the next largest amount of scribe creepage (5.2 and 4.9 mm, respectively; figures 33 and 34). The epoxy mastic and epoxy urethane mastic systems exhibited moderate amount of creepage at the scribe (3.5 and 2.6 mm, respectively; figures 35 and 36). The high-solids epoxy (code no. 2), water-based inorganic zinc/acrylic/acrylic, and water-based zinc-rich epoxy/acrylic/acrylic had a very limited amount of creepage at the scribe. However, all three polyurethane systems (code nos. 5, 6, and 7) performed extremely well without any indication of scribe creepage or other failures.

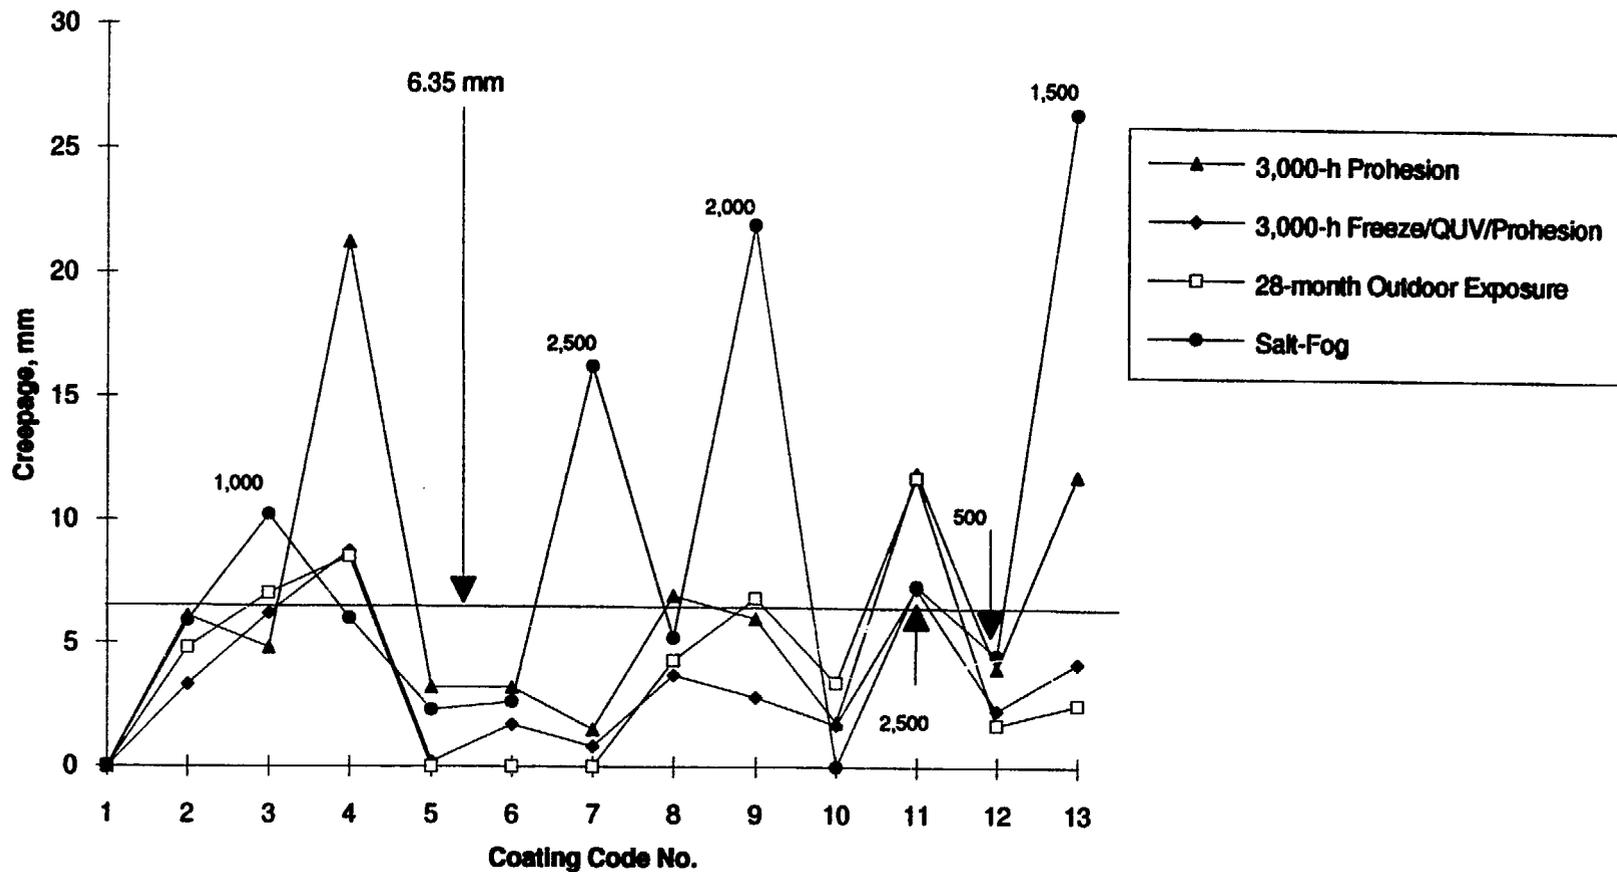
Figure 37. Comparison of creepage for salt-fog exposure, Prohesion exposure, cyclic freeze/QUV/Prohesion exposure, and 28-month outdoor marine exposure.

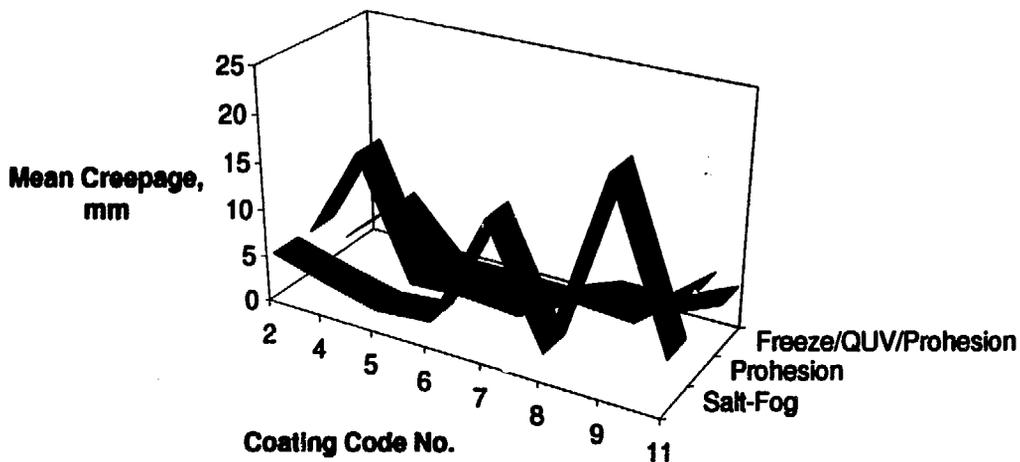
Figure 38. Plot of mean creepage of eight coating systems vs. exposure time for salt-fog test, Prohesion test, and cyclic freeze/QUV/Prohesion test.

The differences in methods and coating systems can also be seen in the plot of averages for scribe creepage using three methods (figure 38). To distinguish the degree of failure by each test method, the mean creepage at the scribes at exposure times of 0, 500, 1,000, 1,500, and 2,000 h is plotted in figure 39. The extent of creepage for the salt-fog test and the Prohesion test are similar up to 1,500 h; above 1,500 h, the salt-fog test caused larger creepage than did the Prohesion test. The cyclic freeze/QUV/Prohesion test produced the least amount of scribe creepage among all three test methods due to its less severe environment.

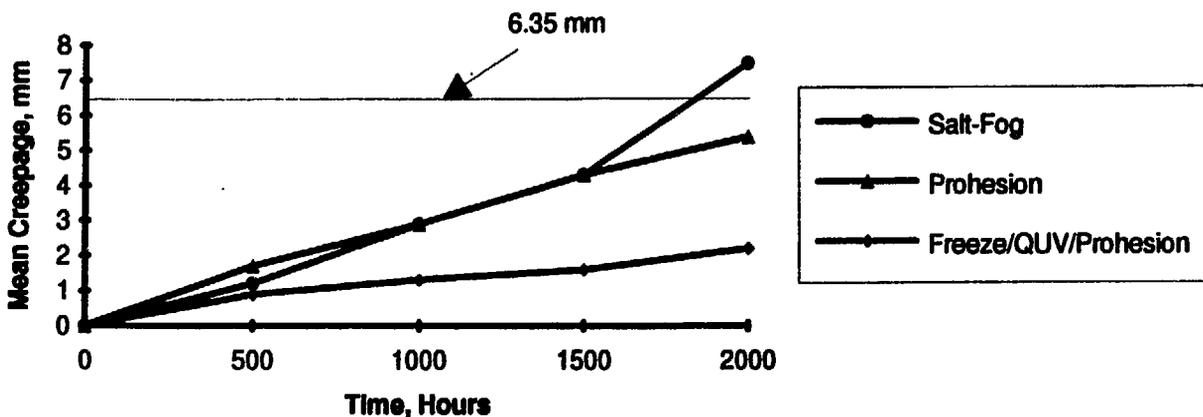
Figure 39. Mean creepage of exposure time of 500, 1,000, 1,500, and 2,000 h for eight coating systems after salt-fog test, Prohesion test, and cyclic freeze/QUV/Prohesion test.

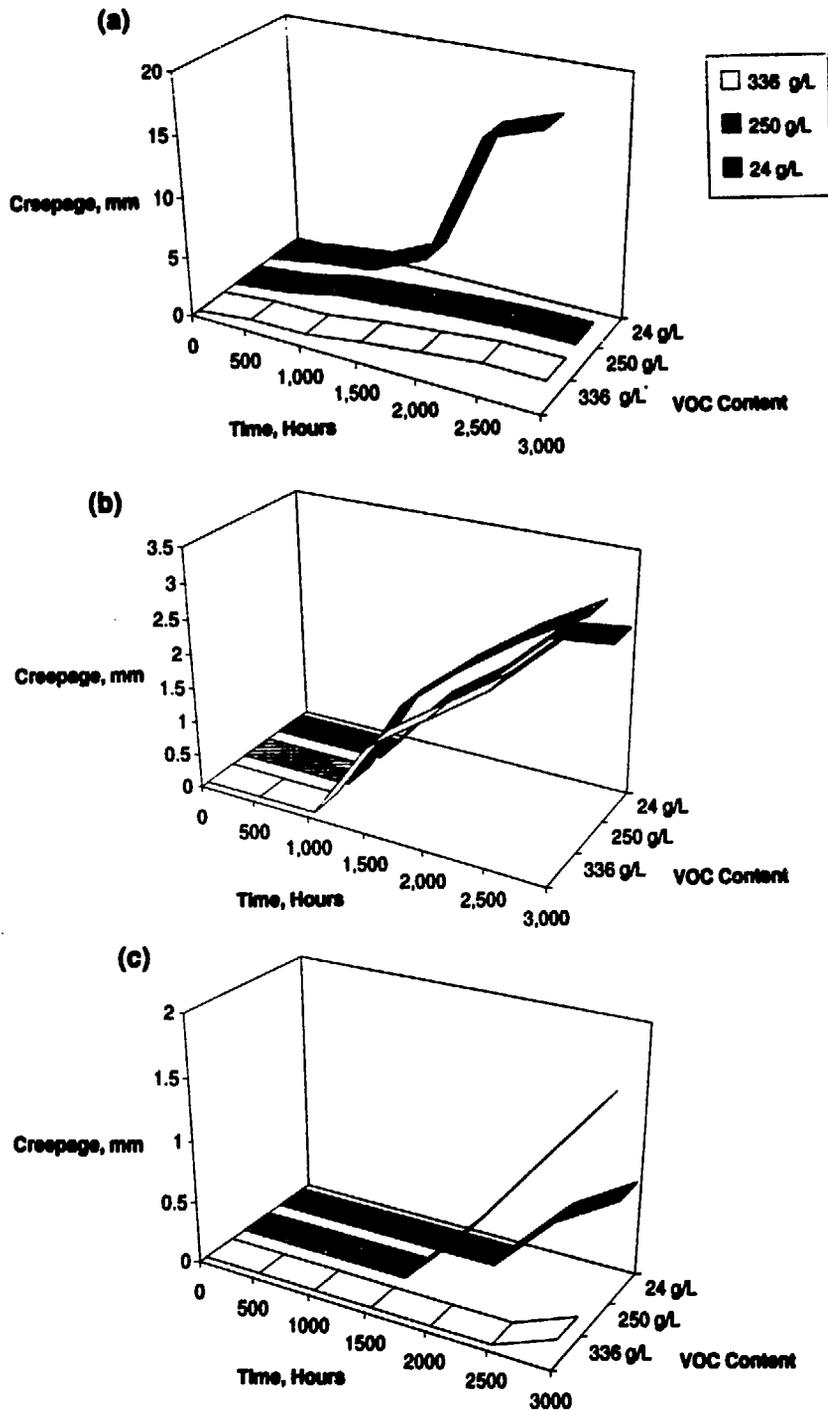
Figure 40. Creepage variation of different VOC content of polyurethane topcoat applied on solvent-based zinc-rich polyurethane: (a) salt-fog exposure, (b) Prohesion exposure, and (c) cyclic freeze/QUV/Prohesion exposure.

The effect of VOC content on the coating performance can be clearly investigated by comparing the scribe creepage of code nos. 5 through 7, which are the polyurethane systems with topcoats containing different solvent content. In the plot of creepage versus exposure time for the salt-fog test (figure 40(a)), the waterborne topcoat system with a VOC of 24 g/L performed the poorest and failed very rapidly after 1,000 h. However, after 1,000 h of exposure, two solvent-based polyurethane systems (code nos. 5 and 6) still showed similar good performance. The coating system with the highest VOC content (VOC = 336 g/L) had the best performance as compared to two lower VOC systems (VOC = 250 and 24 g/L) in the cyclic freeze/QUV/Prohesion test (figure 40(c)). On the contrary, all three systems showed no visible difference in performance in the Prohesion test (figure 40(b)). In general, the performance of the three-coat polyurethane system decreases with decreasing VOC content of the topcoat.
