MISCELLANEOUS PAPER HL-81-6

# AIR DEMAND TESTS, LIBBY DAM KOOTENAI RIVER, MONTANA

E. Dale Hart

Hydraulics Laboratory

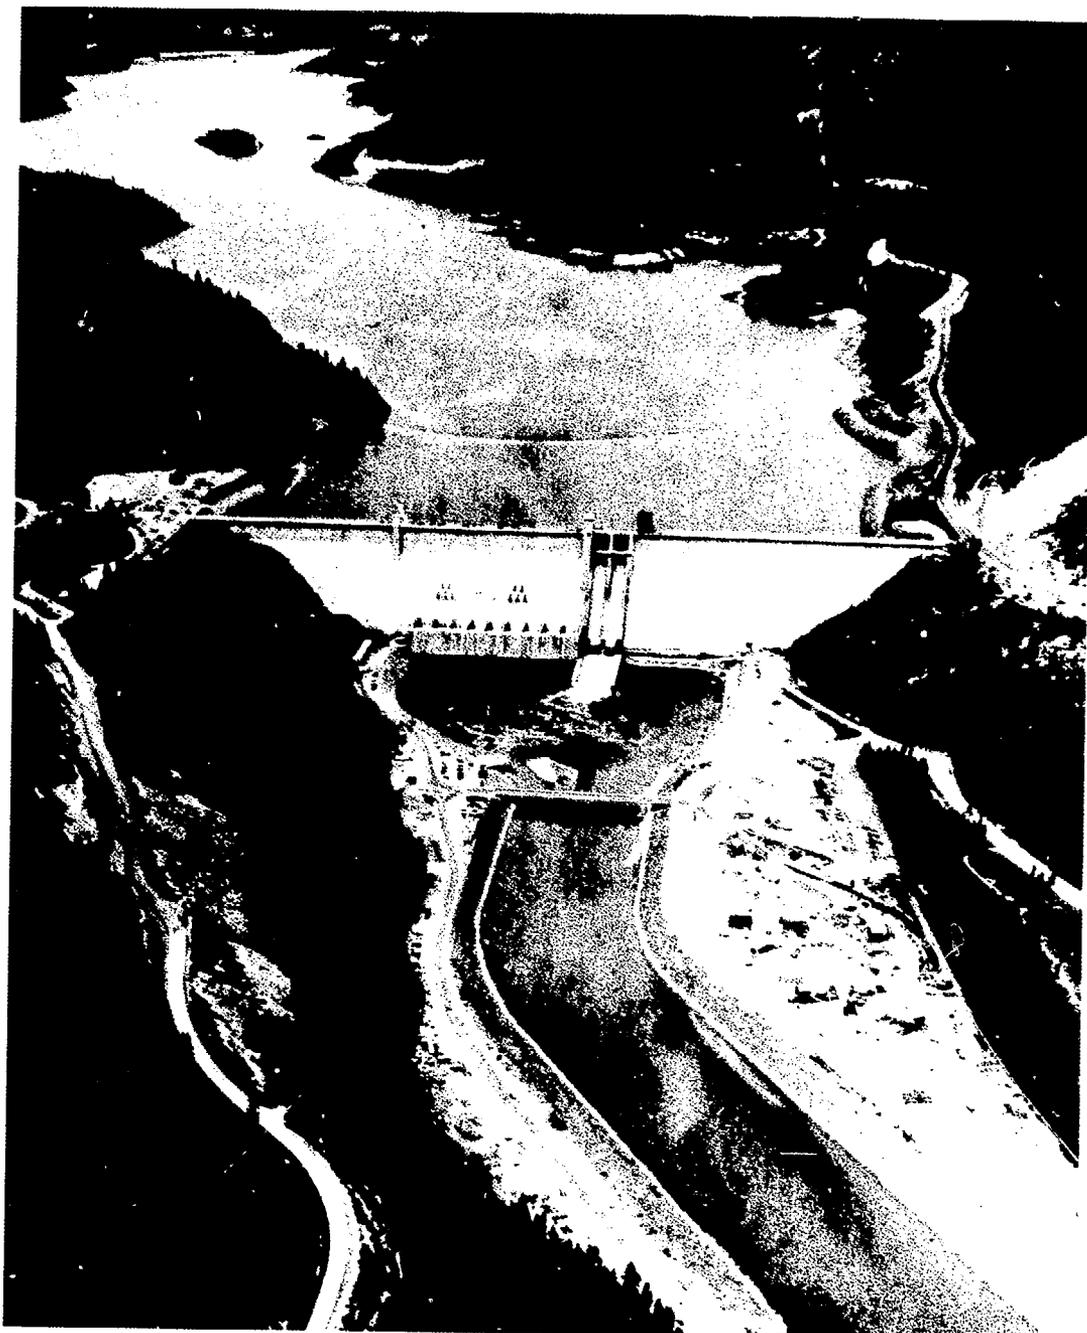
Figure 1. Libby Dam and Reservoir

1. Libby Dam (Figure 1) is located on the Kootenai River in north-western Montana 221.9\* river miles\*\* upstream from its confluence with the Columbia River and approximately 17 river miles above the town of Libby, Montana (Figure 2). It is a multipurpose project constructed as

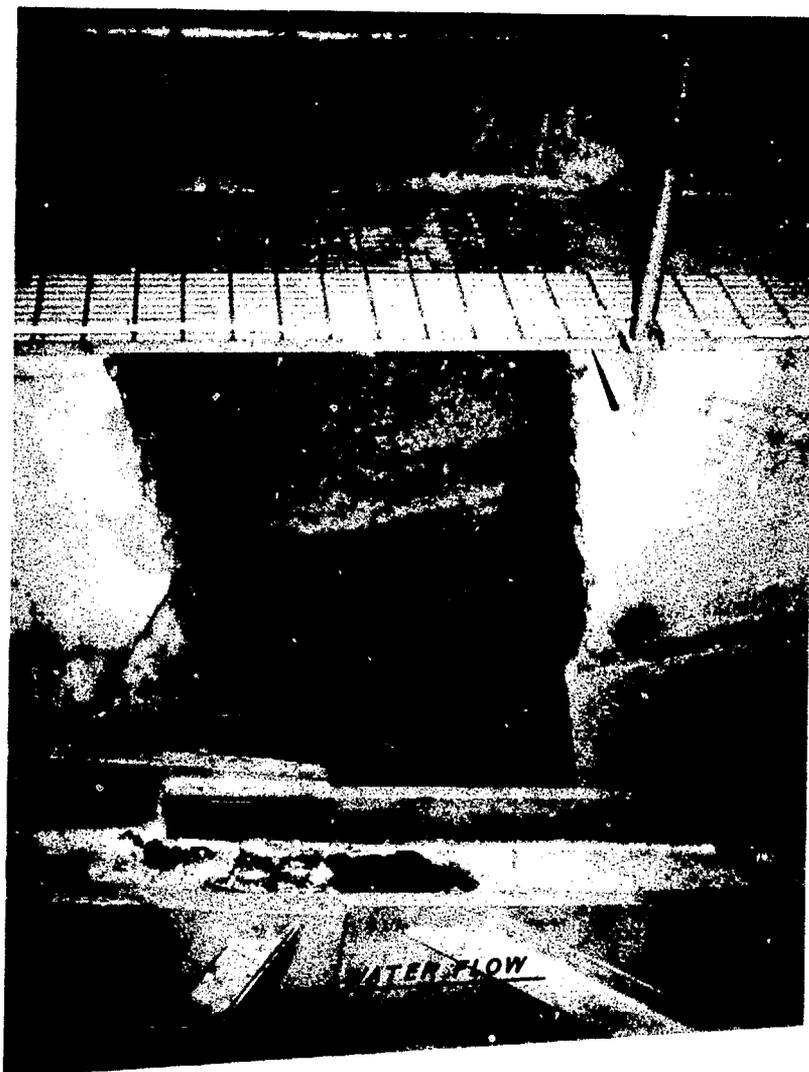
Figure 3. Sluice aerator slot

6. The center sluice of the project receives air indirectly from the outer sluice air vents through crossover passages (Plate 1). Tests were conducted to determine the air drawn into one of the outer sluices as a result of the addition of the aerator. This information would be used to design an independent air vent for the center sluice. A portion of one of the aerators is shown in Figure 3.

5. The recommended aeration system installation, completed by the Seattle District in the summer of 1980, consists of a slot in both side-walls and the floor of each sluice as shown in Plate 1. Observation during initial sluice operation revealed, as expected, a significant increase in air demand above the premodified condition. The Seattle District requested a proposal to measure the air demand during operation of the modified sluices.\*

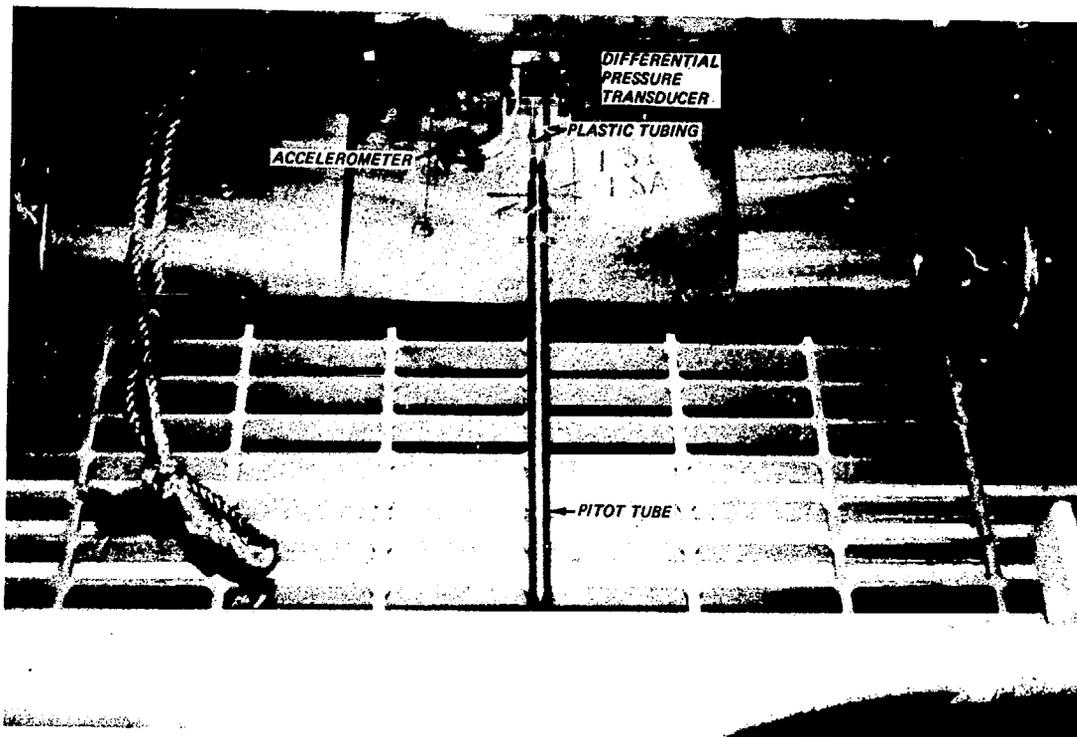
Figure 6. Equipment shaft strut (panel removed) and instrumentation

11. A typical arrangement of the pitot tube, differential pressure transducer, and electrical cables is shown in Figure 6. The transducer is a Validyne DP9 differential pressure transducer with a range of 0 to 0.5 psid. Specifications for all transducers used in the test program are presented in Table 1. Pitot tubes used in the tests were calibrated in a wind tunnel at the National Space Technology Laboratories (NSTL), Bay St. Louis, Mississippi. The calibration provided a correction coefficient for the pitot tubes used in the study.

13. The streamlined struts were fabricated from mahogany. A typical strut cross section is shown in Figure 8. The cross section of each consisted of two ellipses joined at their minor axes. The downstream major axis ( $a_2$ ) was longer than the upstream ( $a_1$ ). The minor axes ( $b$ ) were identical. The struts consisted of two halves, divided along the major axis. Sections of each inner side of the strut were grooved to accommodate the pitot tubes, pressure transducers, accelerometers, and cables, as in Figure 6.

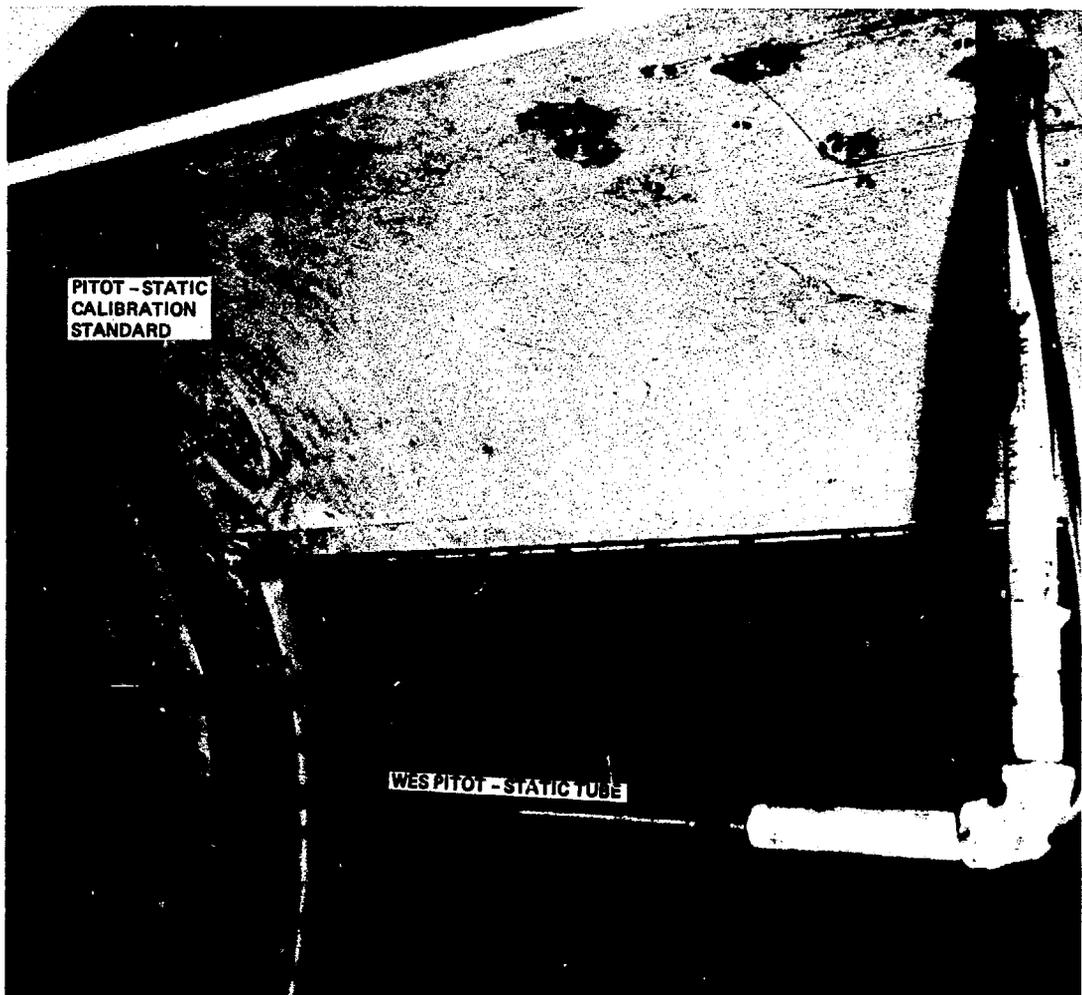
Figure 7. Wind tunnel test section

where  $\Delta p$  (Equation 1) is in psi. The calibrated pitot tube coefficient was calculated to be 351.90 based on information provided by NSTL. A graph comparing the coefficients is presented in Plate 4. The test section of the wind tunnel is shown in Figure 7.

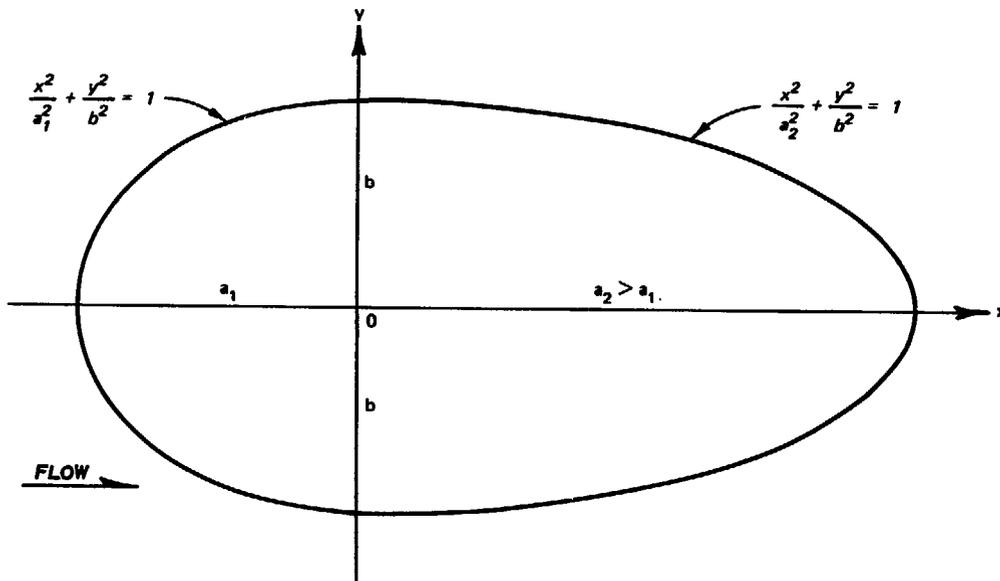
Figure 8. Strut cross section

<u>Strut Location</u>	<u>Cross-Section Dimensions, in.</u>		
	<u><math>a_1</math></u>	<u><math>a_2</math></u>	<u><math>b</math></u>
Air vent	5.00	8.50	2.38
Equipment shaft	4.00	5.50	1.75
Sluice	3.00	3.00	1.25

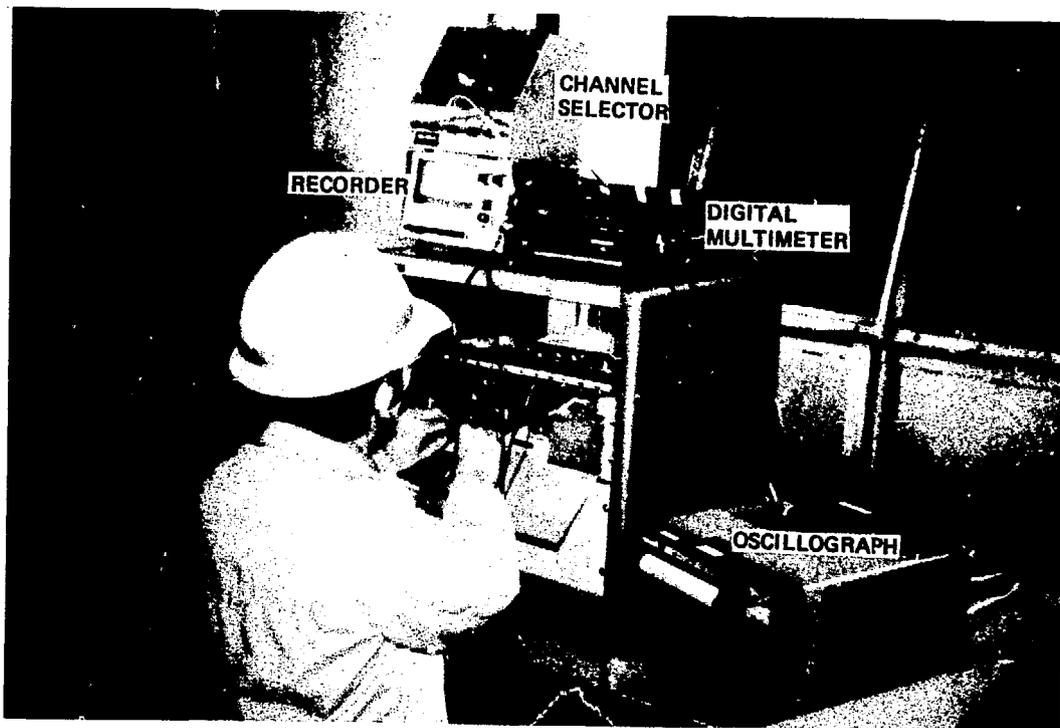
Figure 11. Test recording equipment

19. The recording equipment consisted of: (a) WES-fabricated model 03 bridge amplifiers to condition the strain gage transducers (GC1, AVA, ESA) output signal, (b) a WES-fabricated channel selector, (c) a Validyne CD12 recorder for providing an analog output signal, (d) a Fluke 8300A digital multimeter for displaying the Validyne recorder output voltage digitally (AV1, AV2, AV3, AV4, ES1, SL1, and SL2), and (e) a CEC model 5-124, 7-in. direct print oscillograph capable of reproducing up to 18 channels of data at chart speeds of 1/4 to 64 ips. Chart speeds of 4, 16, and 64 ips were used during the Libby tests. Figure 11 shows the equipment setup at the recording station.

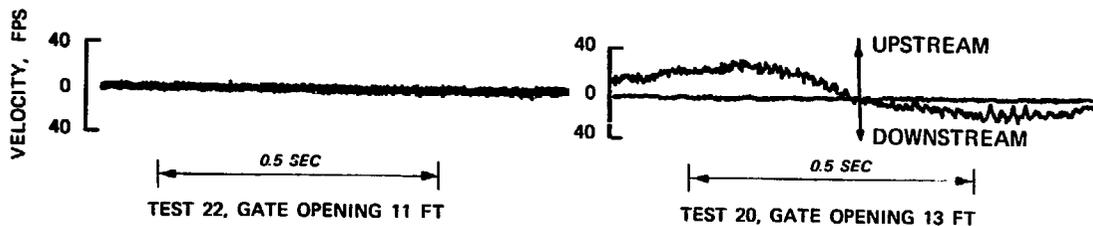
Figure 12. Sluice airflow (SL2)

31. Use of this theoretical approach for computing sluice discharge was complicated by the fact that the velocity data (SL1, SL2) indicated that (a) there was very little airflow at the measurement point for gate openings of 11 ft and less, and (b) the measured flow oscillated in both directions at the higher gate openings. Figure 12 presents an illustration of this phenomenon. For these reasons, it is believed that very little of the air entering the sluice exit actually reached the aerator, instead was drawn back out by shear along the air-water interface.

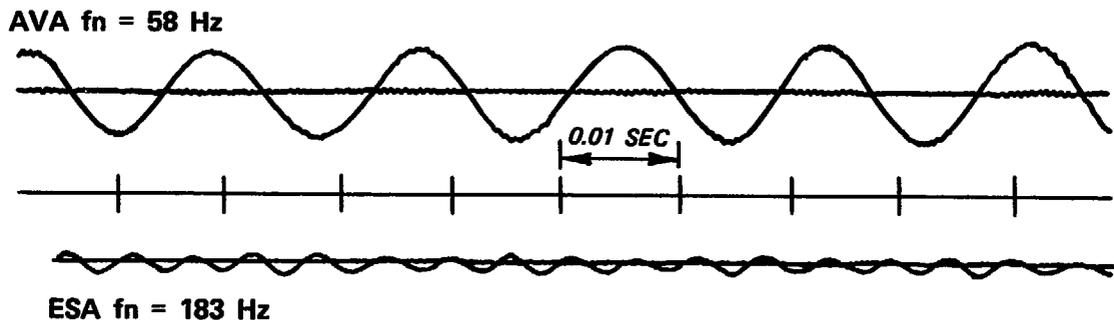
Figure 13. Air vent strut (top) and equipment shaft strut (bottom) "tap" response

35. The aforementioned accelerometers were placed in the equipment shaft and air vent struts to monitor their vibrations. Prior to the tests, each was struck lightly with the butt of the hand and the response recorded. These recordings are shown in Figure 13. During the entire test program, the air vent strut (AVA) vibrated very near its natural frequency. The maximum recorded peak-to-peak displacement was  $5 \times 10^{-3}$  in. at a frequency of 56 Hz and a gate opening of 10 ft. The equipment shaft strut (ESA) maximum displacement was  $7.5 \times 10^{-4}$  in. at 130 Hz (9-ft gate opening).

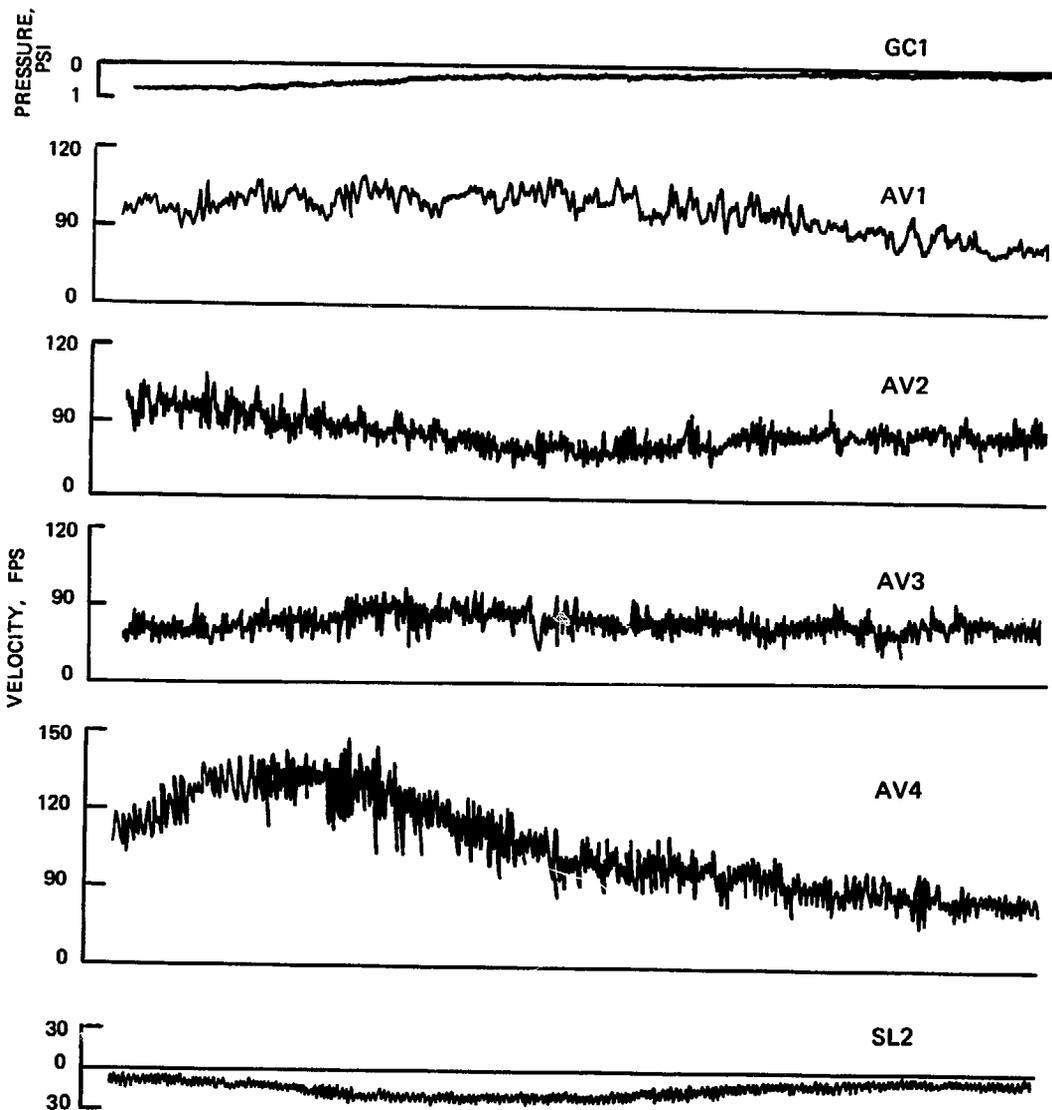
POINT VELOCITIES  
TEST 26, GATE OPENING 7.0 FT  
CHART SPEED 4 IPS

NOTE: (1) EQUIPMENT SHAFT OPEN.

(2) VELOCITY SCALES CONVERTED FROM  
RECORDED PSID DATA:  $V = 351.9\sqrt{\Delta P}$

8. Pitot tube differential pressures were measured at the locations listed in Table 1 and shown in Plate 1 for determining the air velocities in the air vent, equipment shaft, and sluice. For calculating average velocities, the average differential pressure recordings from the oscillograms were used. The largest pitot tube differential pressure observed on either the digital multimeter display or the oscillogram was used in calculating the maximum recorded velocity at each pitot tube for each gate opening. Typical oscillograms are shown in Plates 2 and 3.

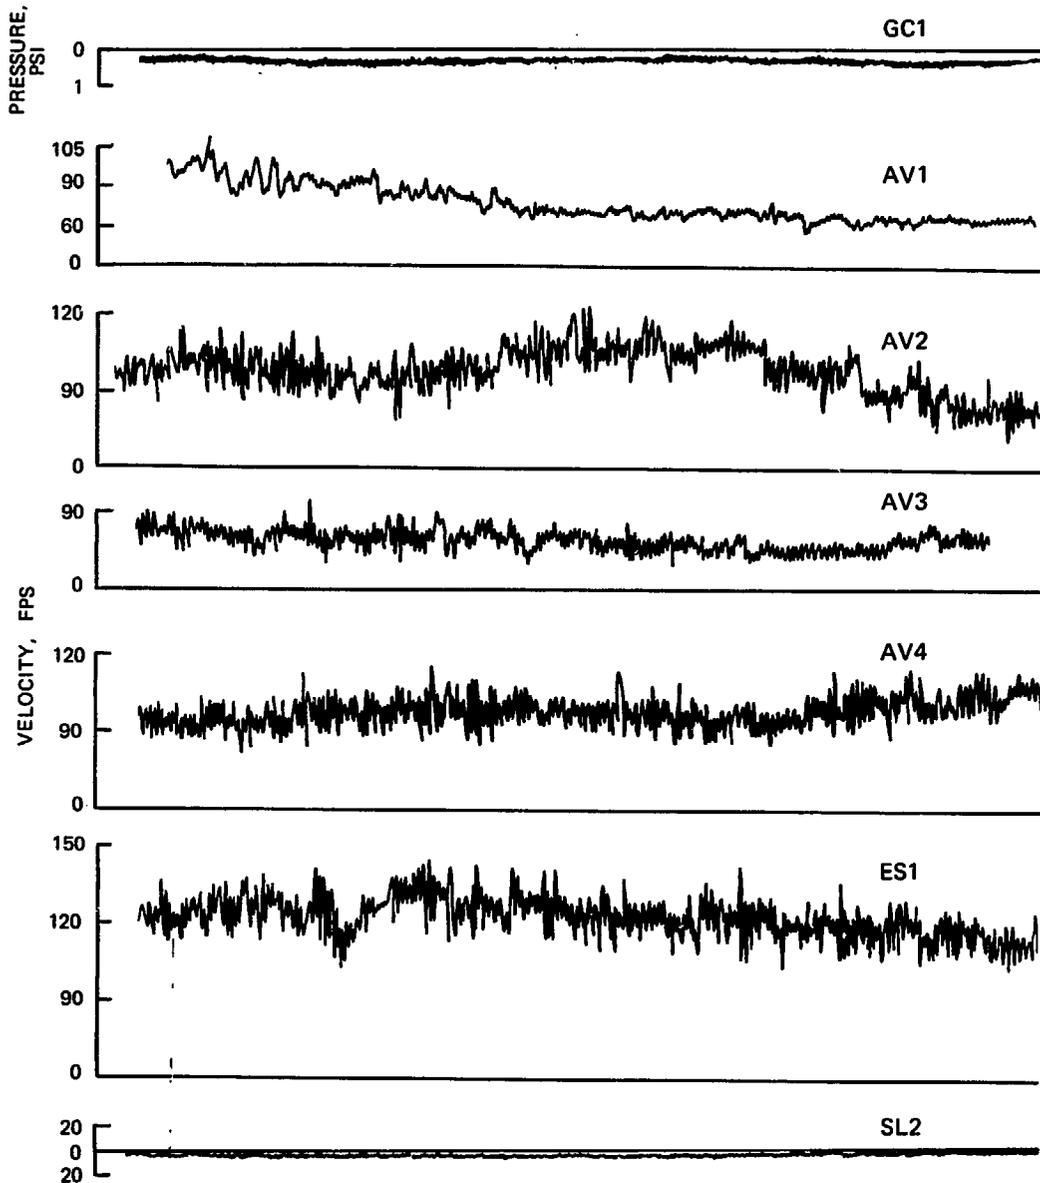
POINT VELOCITIES  
TEST 9, GATE OPENING 9.0 FT  
CHART SPEED 4 IPS

NOTE: (1) EQUIPMENT SHAFT OPEN.

(2) VELOCITY SCALES CONVERTED FROM  
RECORDED PSID DATA:  $V = 351.9\sqrt{\Delta P}$

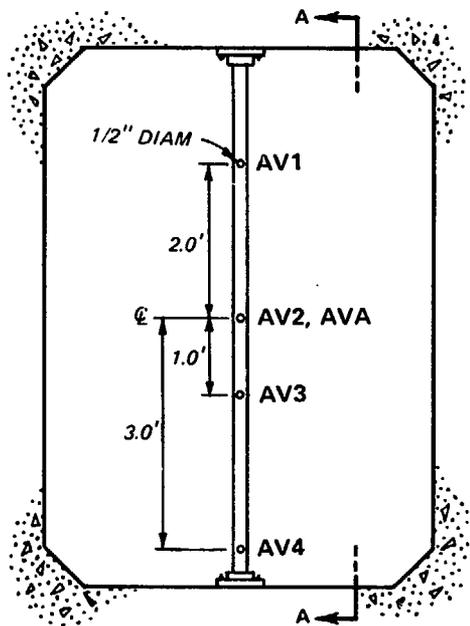
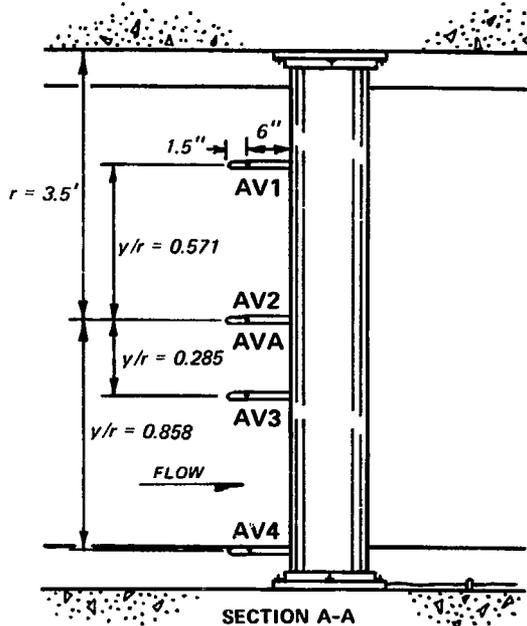
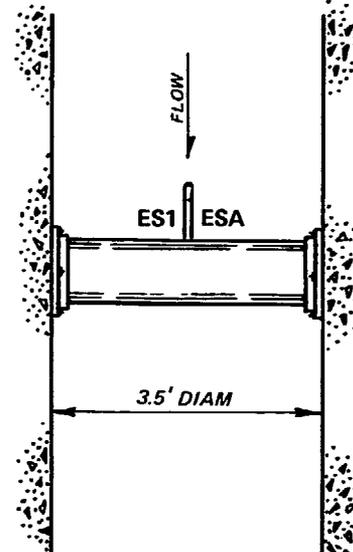
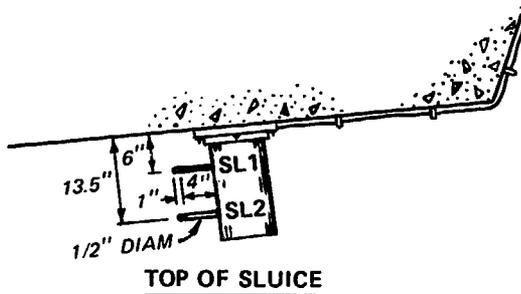
**AIR DEMAND TESTS**  
**VELOCITY PROBE LOCATIONS**

**5' X 7' AIR VENT**  
**AREA = 34.5 SQ FT**

**3.5' DIAM EQUIPMENT SHAFT**  
**AREA = 9.62 SQ FT**

15. The pitot tube and accelerometer arrangements are presented in Table 1 and Plate 5. The equipment shaft pressure transducer (ES1) and accelerometer (ESA) were located in the center of the strut. The distance ratios ( $y/r$ ) from the air vent strut center line to the pitot tubes are shown in Plate 5. The sluice strut was attached to the sluice roof as shown in Figure 10 and Plate 1. The pitot tubes were located 6 and 13.5 in. from the roof; this was necessary to keep them dry during the higher gate openings.

26. Point velocities were measured at four vertical locations in the air vent as shown in Plate 5. The strut was located 57 ft downstream of the vent entrance or 9.8 equivalent diameters ( $D_e = 5.75 \text{ ft}$ ). The strut was situated in this forward position in an attempt to minimize back-pressure effects in the relatively short vent ( $15.4 D_e$ ) which exits at a right angle into the gate chamber.

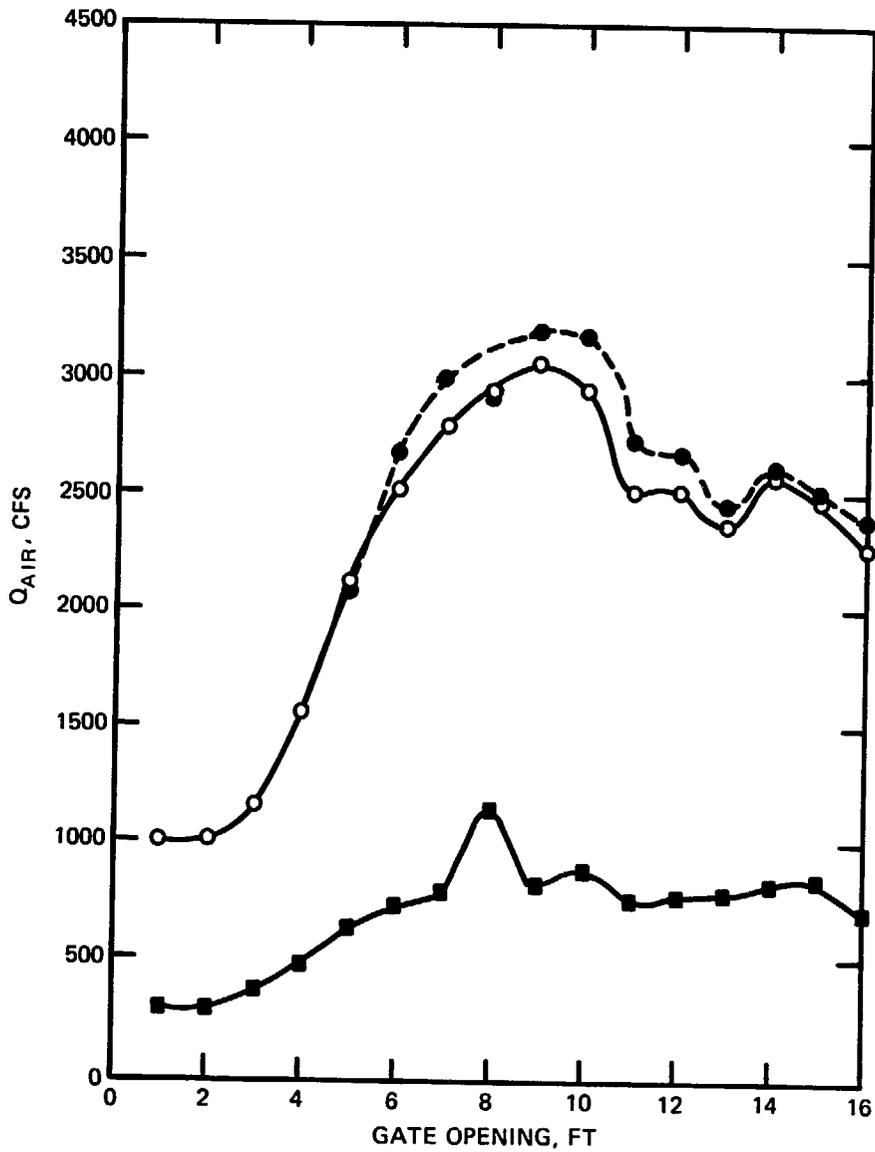
AVERAGE AIRFLOW  
VERSUS GATE OPENING

- E EQUIPMENT SHAFT (ES)
- AIR VENT, ES OPEN
- AIR VENT, ES CLOSED

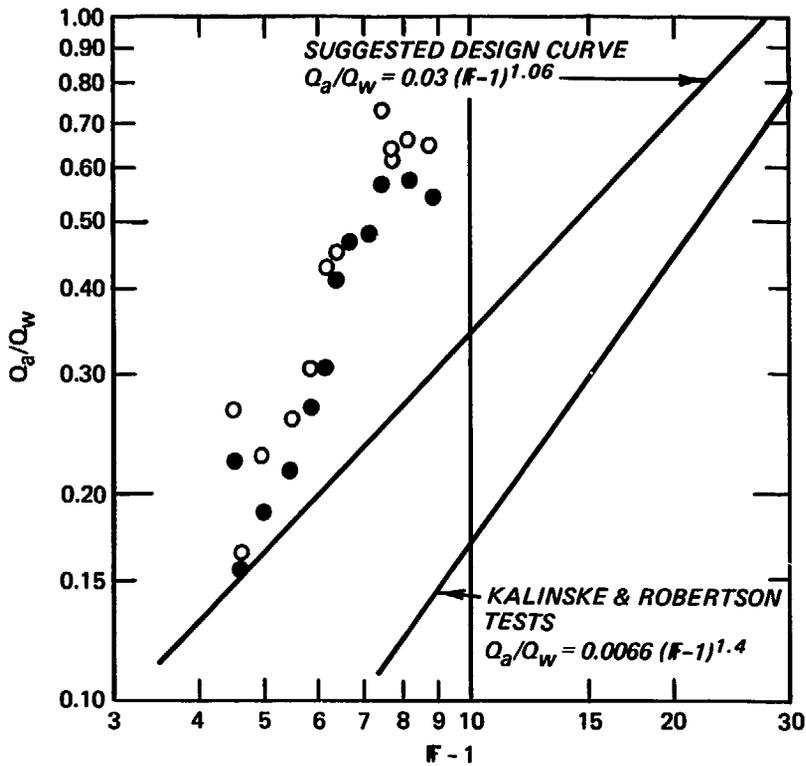
**AIR DEMAND**

**LIBBY DATA, EQUIPMENT SHAFT CLOSED**

- AVERAGE AIR VENT FLOW
- MAXIMUM MEASURED AIR VENT FLOW

FROM HDC 050-1

determined to be 0.080 and 0.095 for the average and maximum recorded point velocities, respectively. In other words, on the average, the respective standard deviations were 8.0 and 9.5 percent of the mean. This implies that the assumption of uniform velocity distribution at the strut is reasonable. These mean velocities were multiplied by the air vent area ( $34.5 \text{ ft}^2$ ) to determine the discharge. Air vent discharge versus gate opening is presented in Plate 6 with the equipment shaft open and closed. Note that the discharge is approximately the same in each case. Table 4 presents the average and maximum computed air vent discharges. The maximum values are approximately 20 percent and 25 percent greater than the average values with the equipment shaft open and closed, respectively. Tables 2 and 3 present the observed maximum and average air vent point velocities which were used in the air discharge computations. The four point velocities used in each computation were not recorded simultaneously. Plate 7 presents the air to water discharge ratio as a function of the Froude number plotted on the Hydraulic Design Criteria Chart 050-1.
