**REPAIR, EVALUATION, MAINTENANCE, AND
REHABILITATION RESEARCH PROGRAM**

TECHNICAL REPORT REMR-CS-1

**ENGINEERING CONDITION SURVEY
OF CONCRETE IN SERVICE**

DEPARTMENT OF THE ARMY
Waterways Experiment Station, Corps of Engineers
PO Box 631
Vicksburg, Mississippi 39180-0631

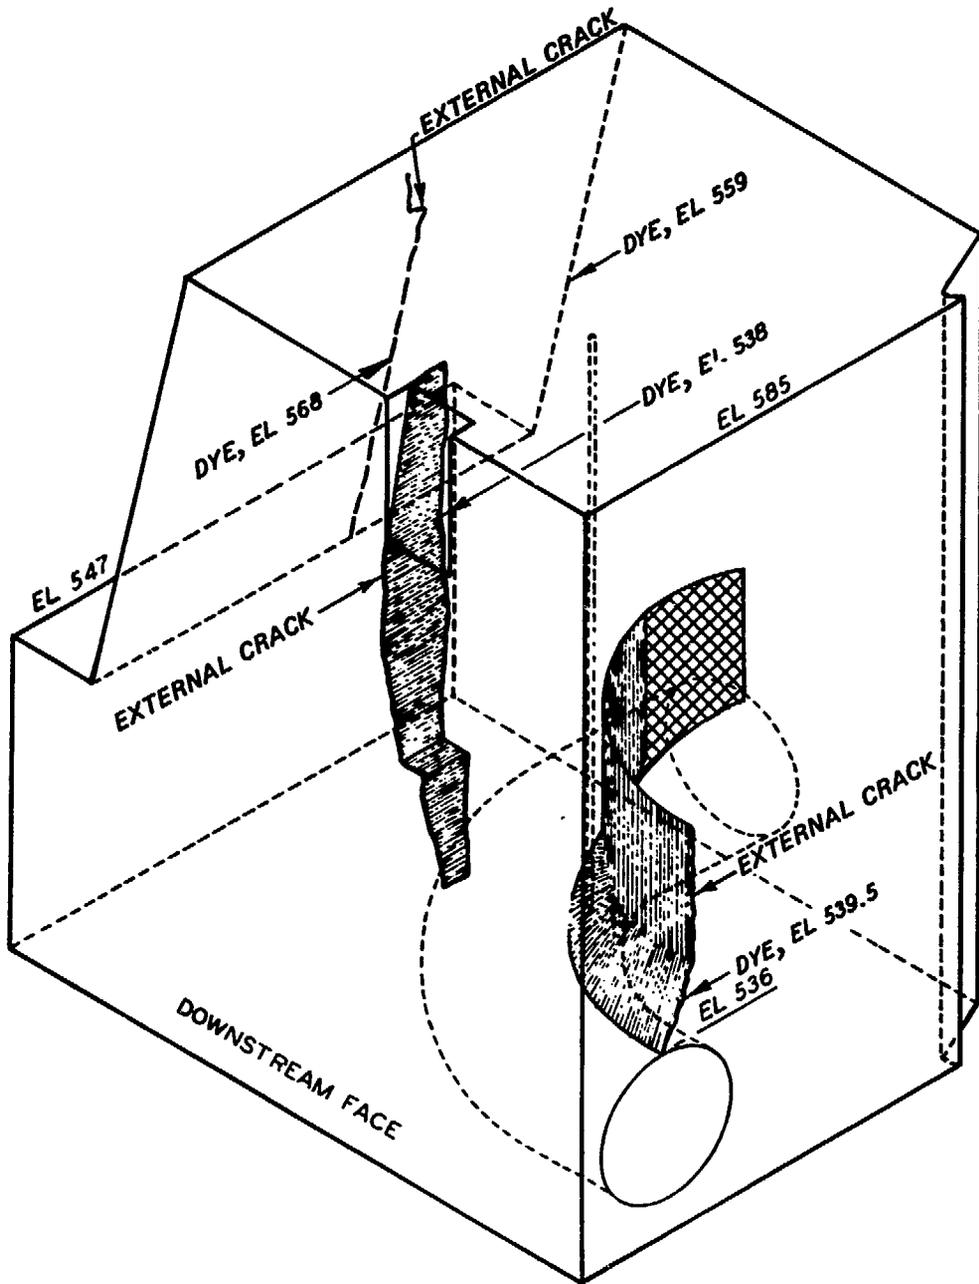
Figure 1. Extent of cracking, downstream gate monolith, river wall, Lockport Lock, Illinois Waterway

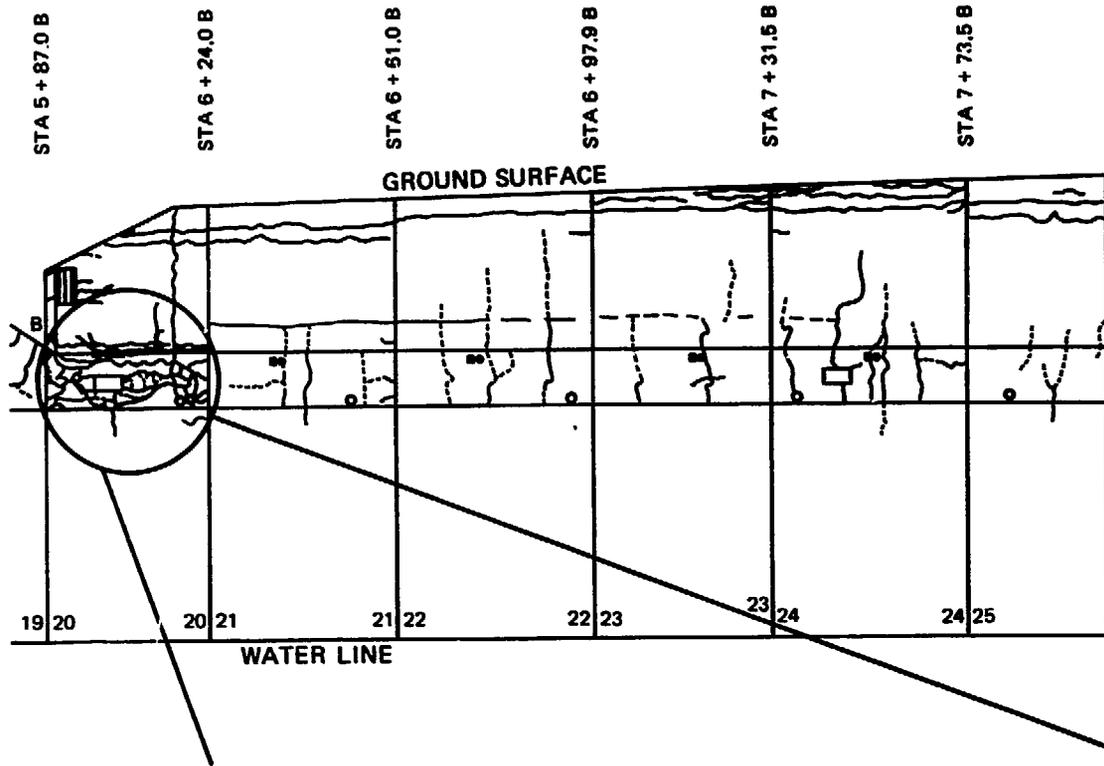
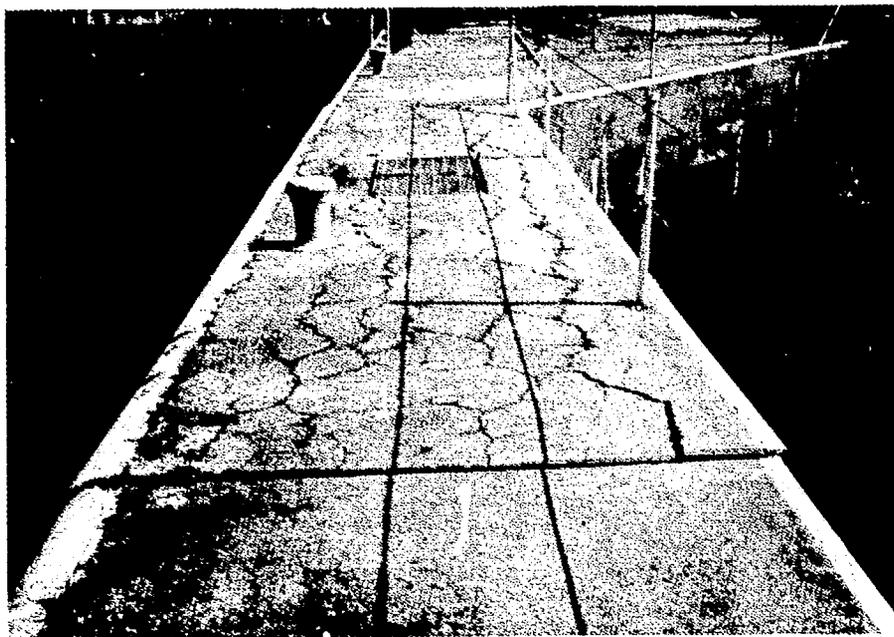
PHOTOGRAPH TOP OF GUIDE WALL
LOOKING UPSTREAM
MONOLITH NO. 20

Figure 2. Surface crack mapping, land wall, and lower end
(after McDonald and Campbell 1977)

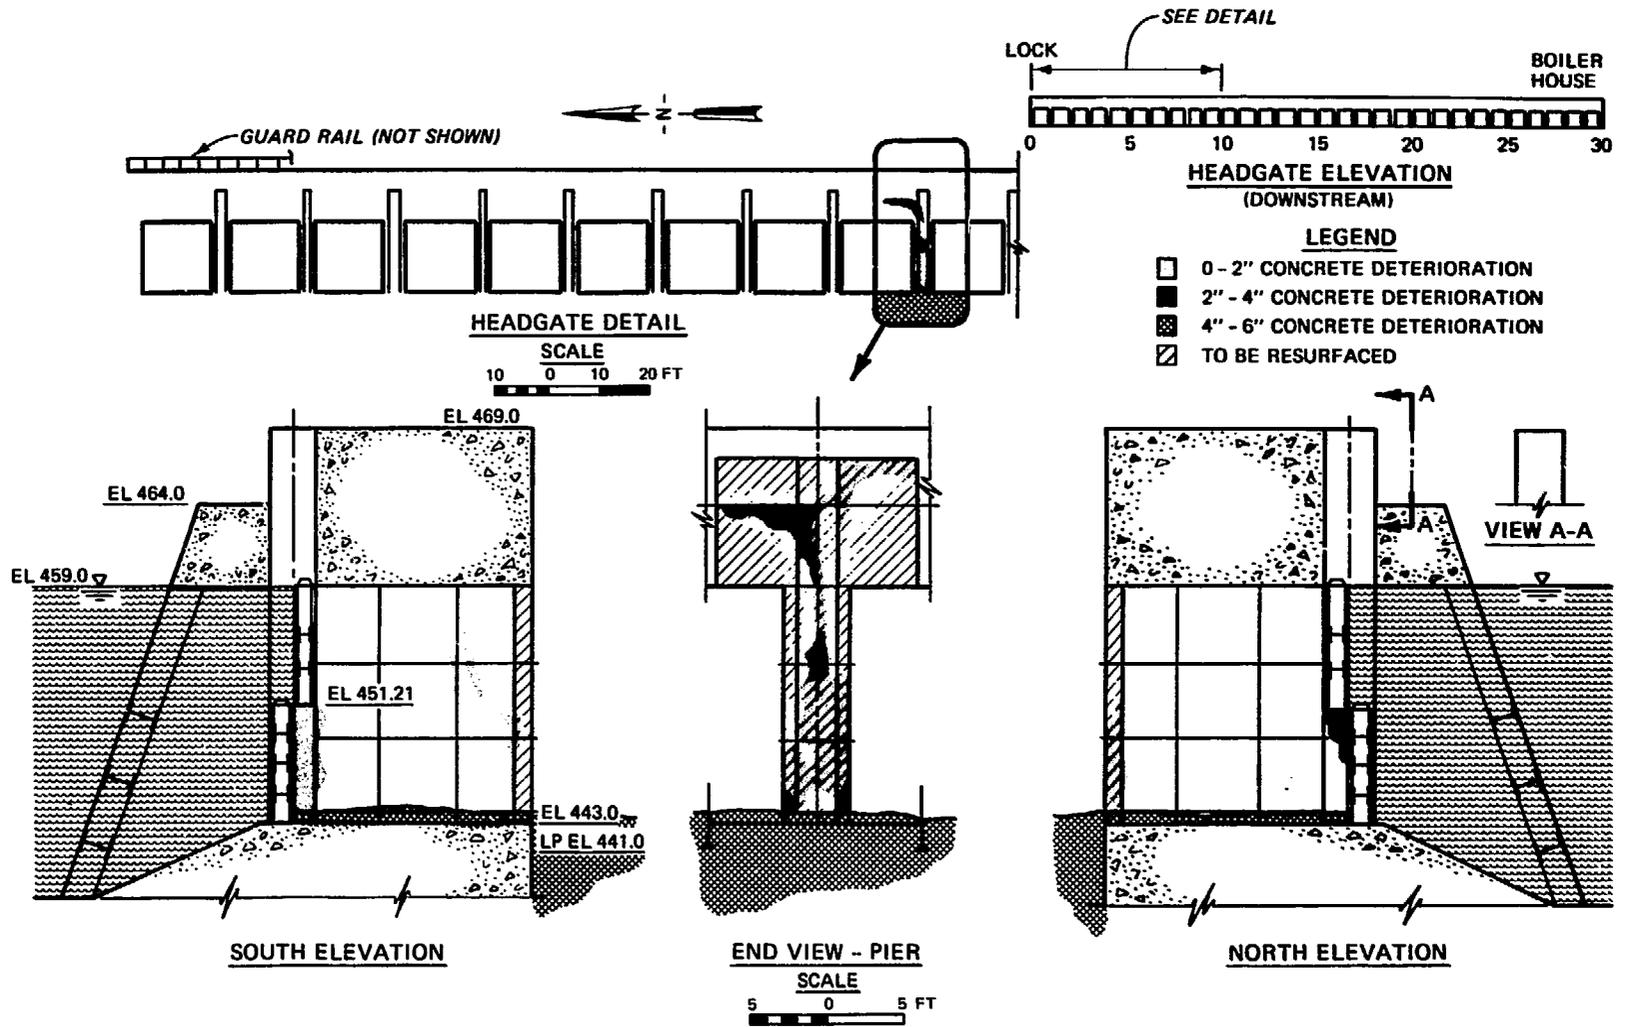
Figure 3. Mapping concrete surface deterioration (after U. S. Army Engineer District, Chicago 1977)

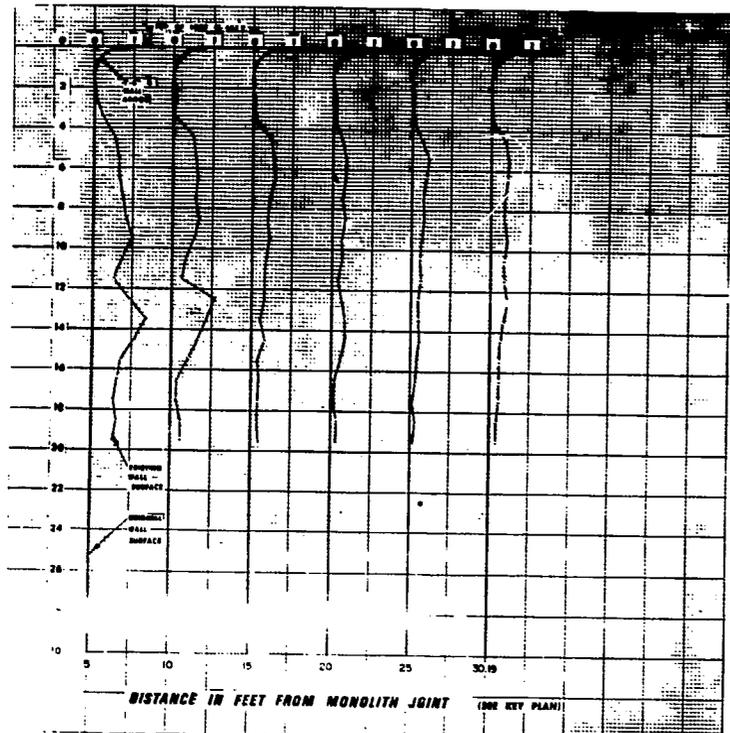
U. S. ARMY ENGINEER DISTRICT CORPS OF ENGINEERS CHICAGO OFFICE	
PROJECT NO.	STARVED ROCK LOCK & DAM MAJOR REHABILITATION LOCK IMPROVEMENT
DATE	MONOLITHS 49 & 51
BY	
CHECKED BY	
APPROVED BY	
DATE

Figure 4. Lock wall profile indicating loss of concrete on lock wall (after U. S. Army Engineer District, Chicago 1977)

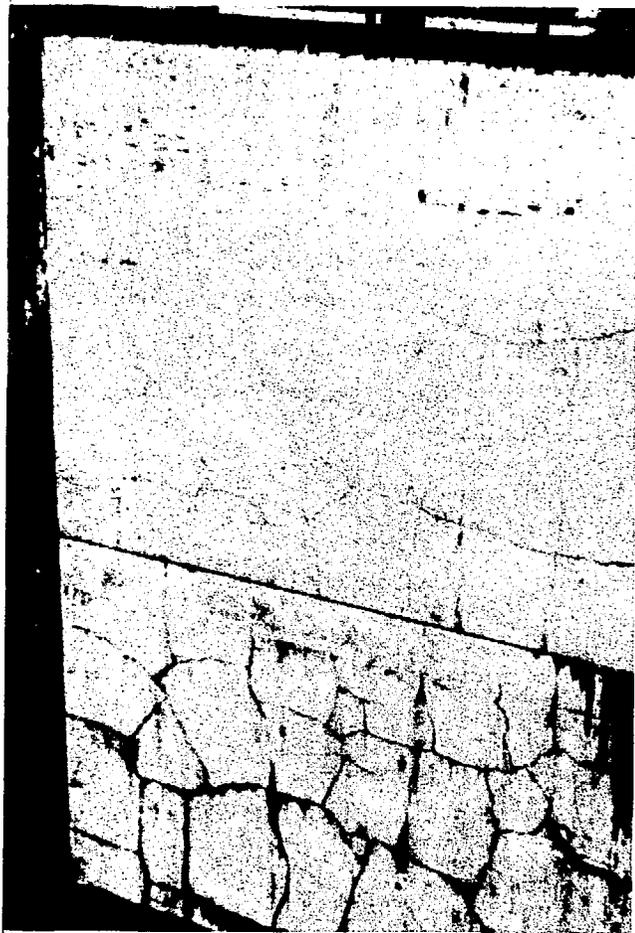
Figure 6. Thermal cracking in lock wall resurfacing concrete

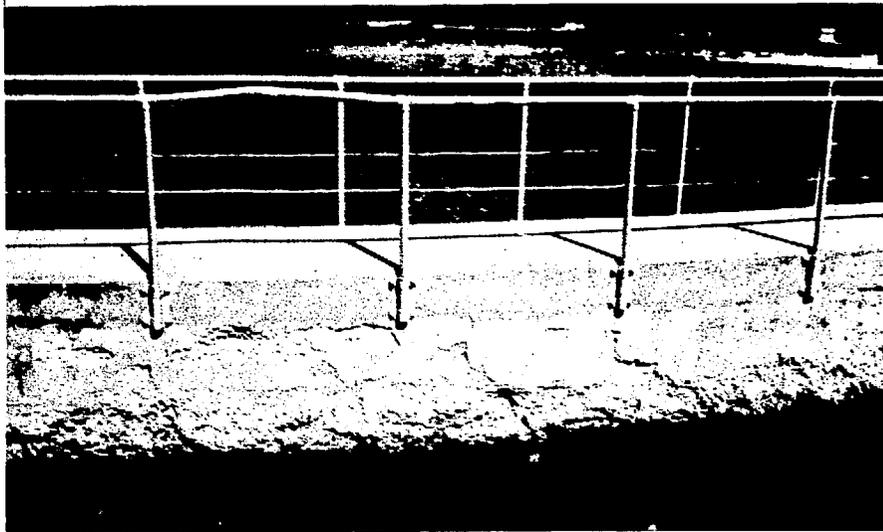
Figure 7. Evidence of freezing and thawing

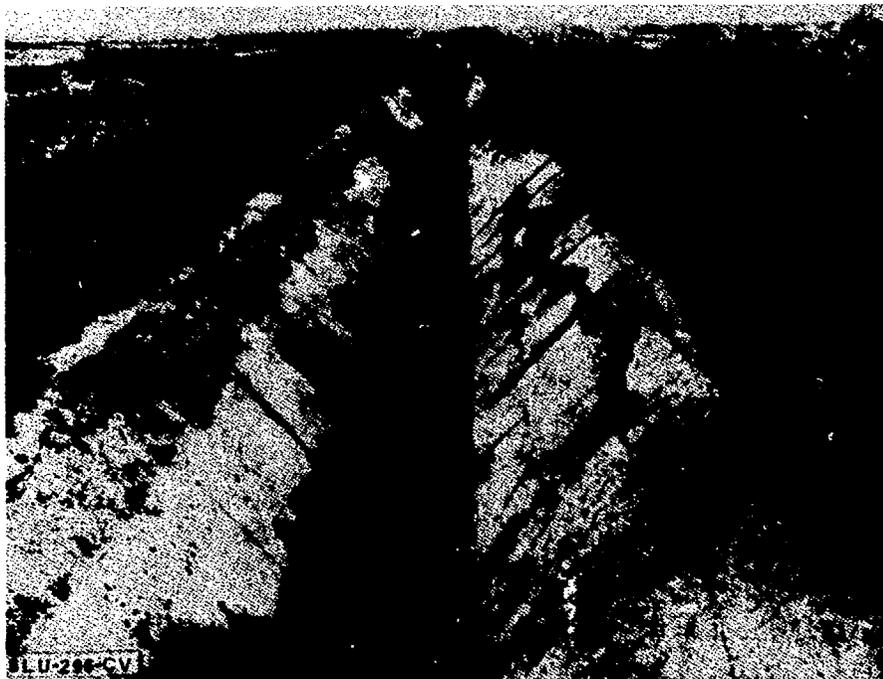
Figure 8. Concrete-lined ditch approximately 1 mile north of Delta-Mendota Canal, California. Concrete containing Type I cement was placed in 1957 and photographed in 1962 (after Bellport 1968)

damage to a concrete-lined irrigation ditch exposed to sulfate conditions (Bellport 1968).

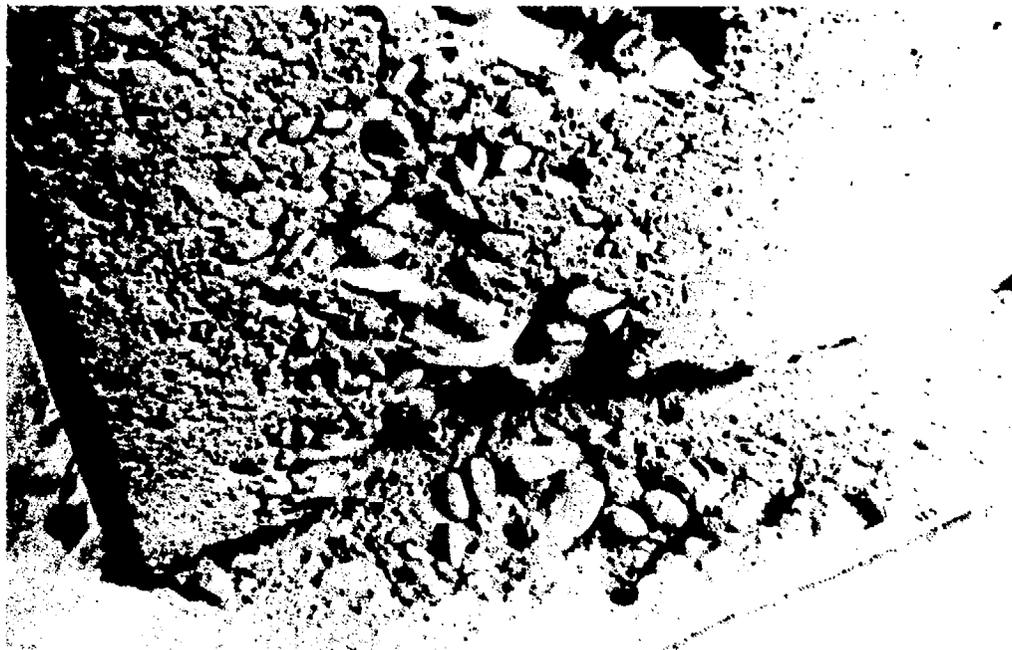
Figure 14. Photograph illustrating cavitation of concrete;
note characteristic pitted surface

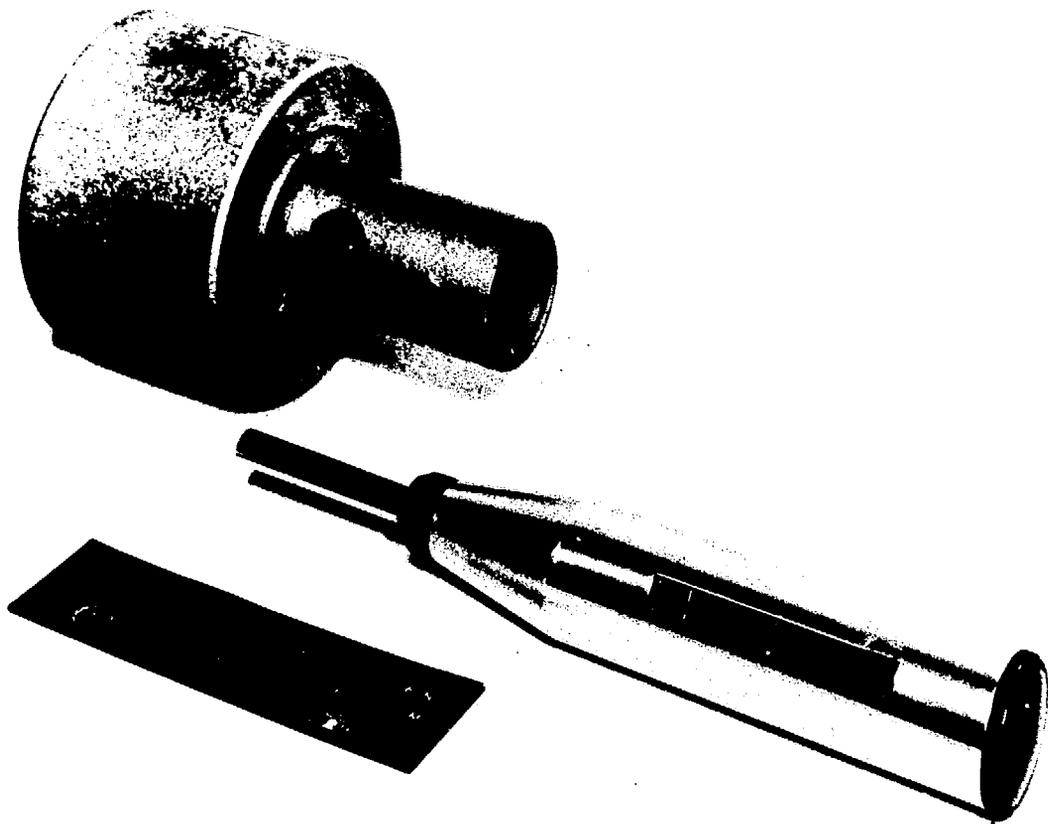
Figure 17. Schmidt hammer and calibration anvil

85. Rebound hammer. The rebound hammer, also called the Swiss or Schmidt hammer (see Figure 17), is used to assess the uniformity of concrete in place and to delineate zones or areas of poor quality concrete.

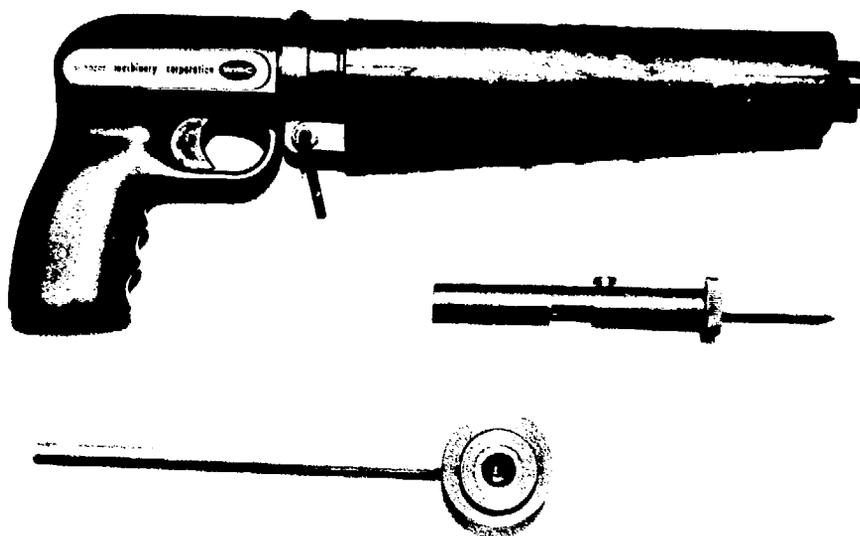
Figure 18. Windsor probe with accessory equipment

91. "The Windsor probe test is basically a hardness tester and, like other hardness testers, should not be expected to yield absolute values of strength of concrete in a structure. However, like the Schmidt rebound hammer, the probe test provides an excellent means for determining the relative strength of concrete in the same structure or relative strengths in different structures without extensive calibration with specific concretes" (Malhotra 1976).

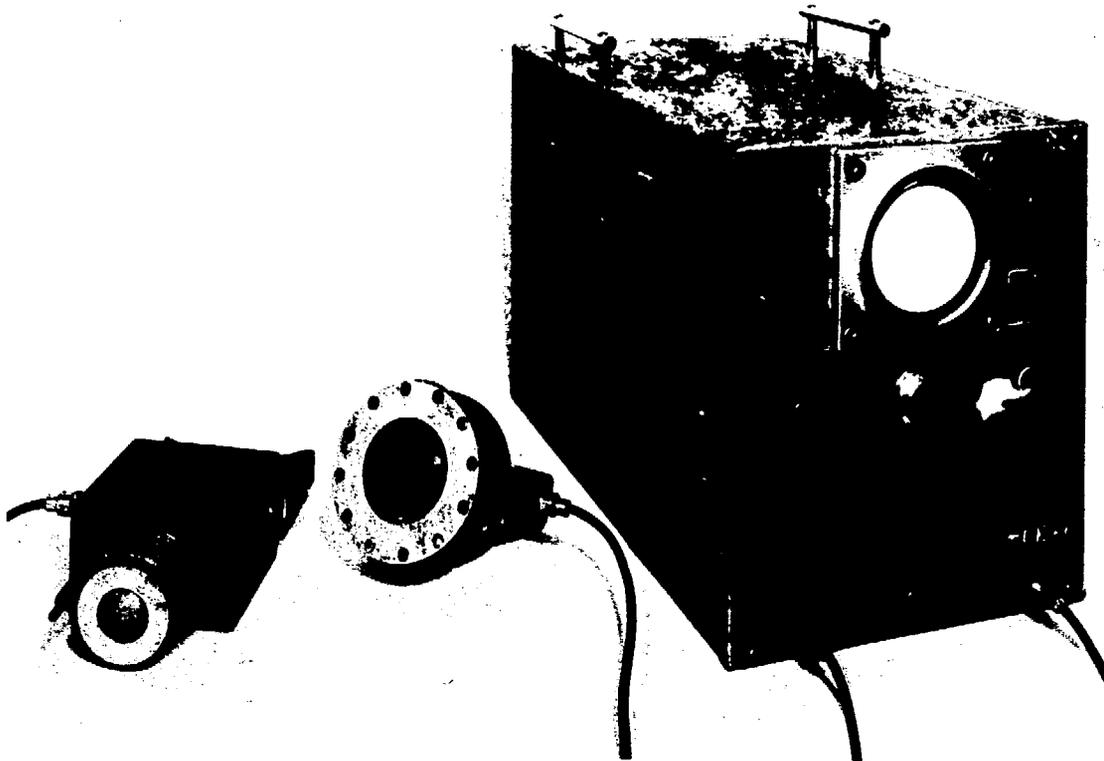
Figure 19. Ultrasonic pulse velocity apparatus

98. The ultrasonic pulse velocity is probably the most widely used method for the nondestructive evaluation of in-place concrete and for

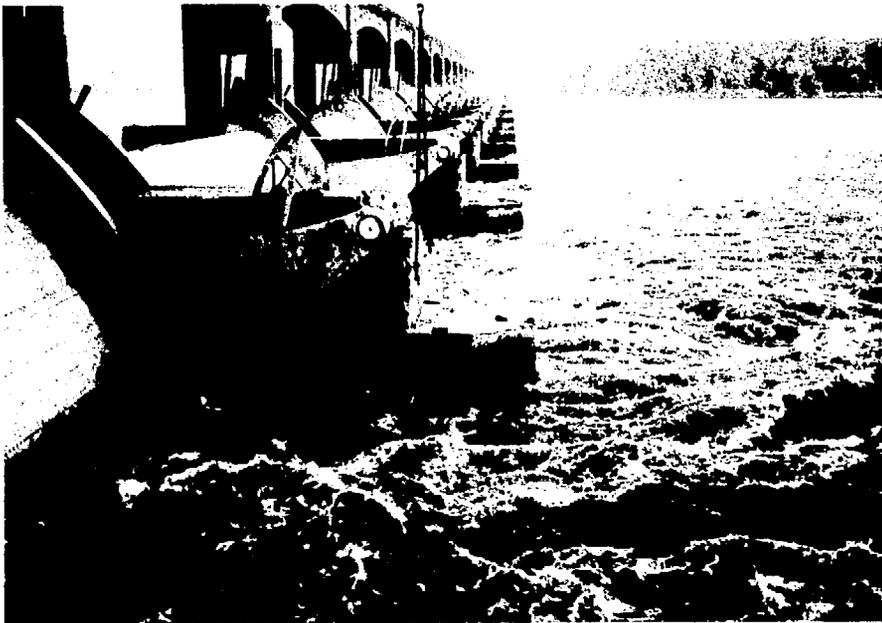
Figure 20. Piers at Lock and Dam No. 24, Mississippi River, with wooden platform in place to facilitate pulse velocity measurement

100. A similar investigation (Thornton and Glass 1980) was performed at Lock and Dam No. 24 on the Mississippi River where ultrasonic velocity measurements were made through 14 concrete piers (see Figure 20) which constitute

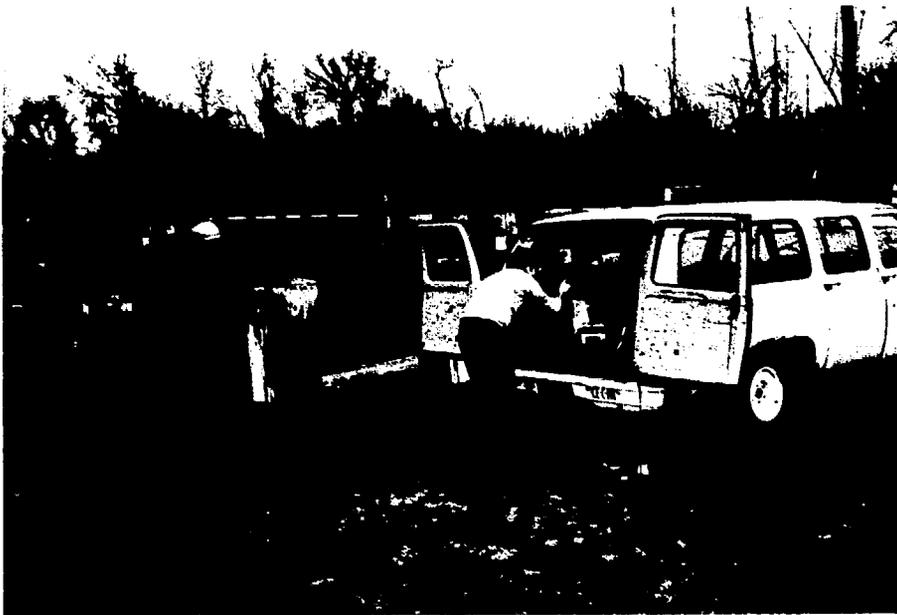
Figure 21. Making pulse-echo measurements on driven piles in high damping environment

104. In May 1977, an inquiry was received from the Savannah District concerning the availability of a method or technique for determining the depth of driven concrete piles which serve as foundation and support piers for a concrete loading wharf in Kings Bay, Georgia. After limited field testing, a short-term sonic pulse-echo investigation was performed in early June 1977. The performance of the system and the overall results of the investigation were considered to be acceptable, but difficulty with signal analysis because of extraneous reflections left some questions unanswered. At this point in development, successful pulse-echo measurements can be made on driven piles (see Figure 21), drilled piers in low-damping environments (water, sandy soil, etc.), and where extraneous reflections caused by adjoining elements are minimal.

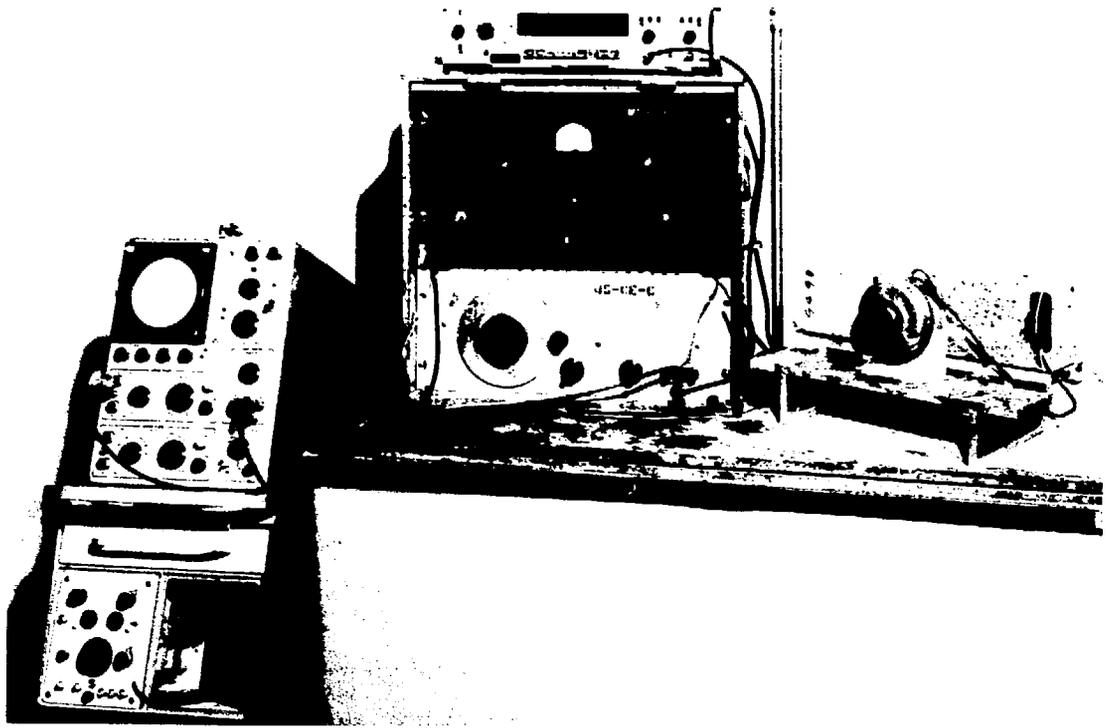
Figure 22. Laboratory resonant frequency vibration apparatus

105. Resonant frequency. As stated by Thornton (1977), the resonant frequency method (see Figure 22), CRD-C 18-59, involves determination of natural frequencies of vibration in concrete specimens. Frequencies of vibration are then utilized to determine various physical properties of the specimens.

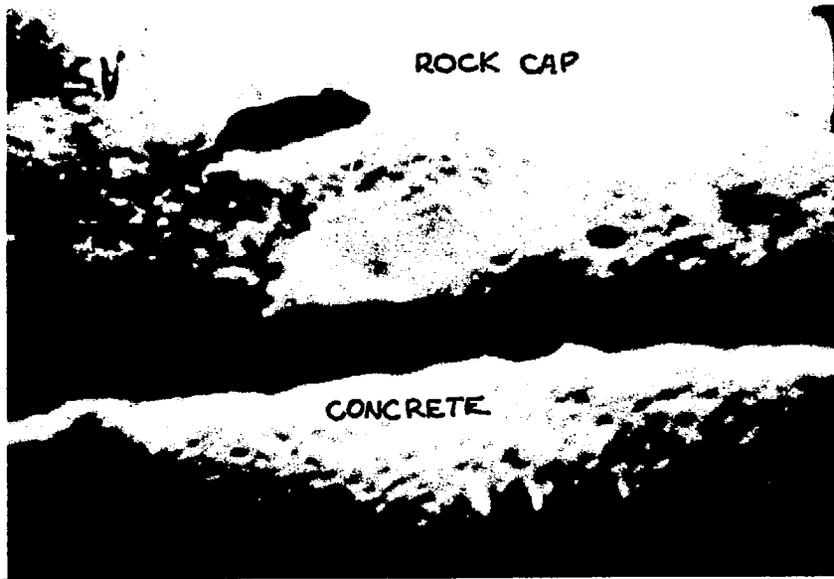
a. Horizontal cracks, average width 4.5 mm, open contact between capping block and concrete (Montreal Engineering Company, Limited 1981). Rock cap overlays the concrete portion of a pier

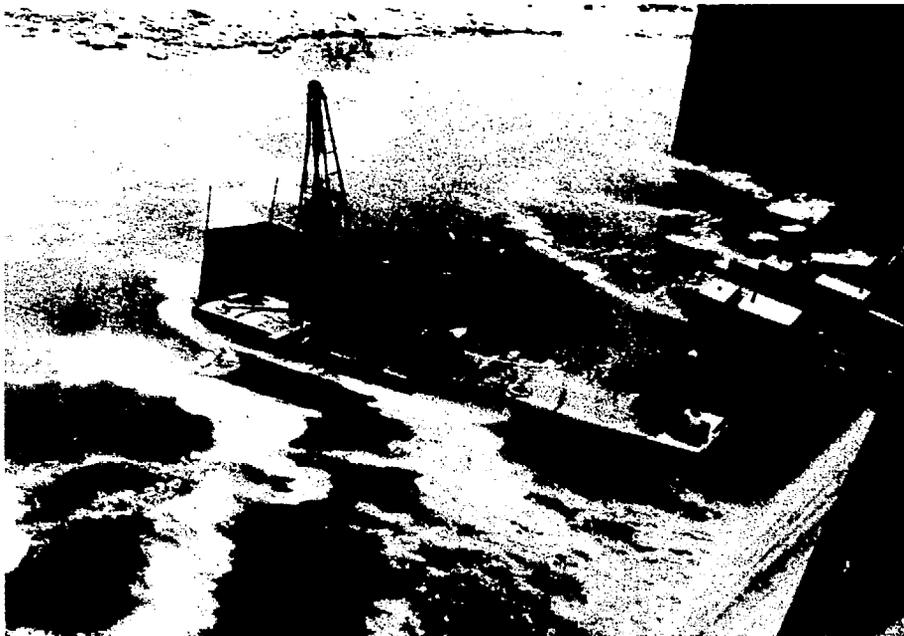
Figure 29. Floating plant with drill equipment behind dam, Brandon Road Lock and Dam, Illinois Waterway

8- by 20-ft barge with drilling well and skid rig, have been used in areas which are difficult to reach, such as behind a dam. Figures 29 and 30 illustrate drilling behind a dam and on a vertical surface to obtain horizontal cores.

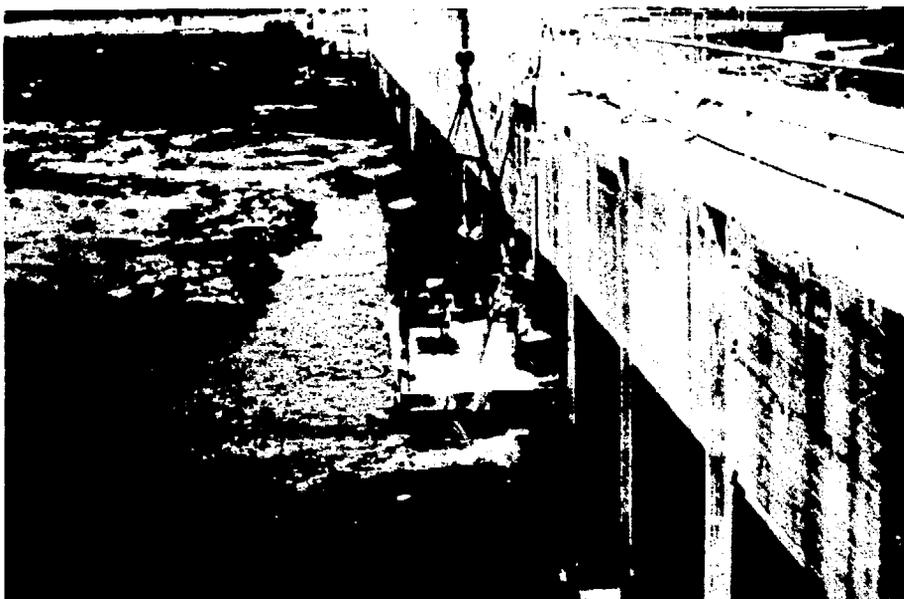
Figure 30. Crane supporting horizontal drilling operation, Starved Rock Lock and Dam, Illinois Waterway

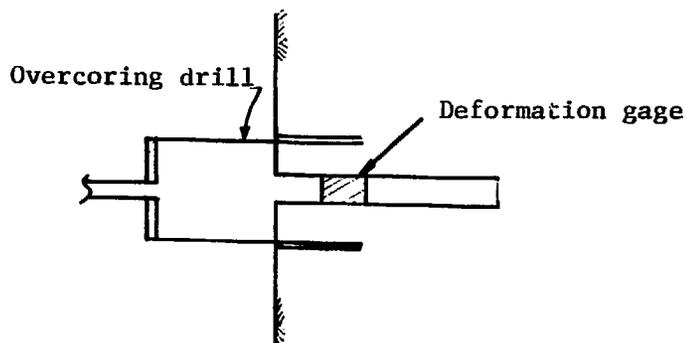
Figure 32. Borehole stress-relief technique

measure diametral deformation during over coring along three diameters 60 deg apart in a plane perpendicular to the walls of a 1-1/2-in.-diam borehole. The 1-1/2-in. hole is over cored with a 6-in. core barrel; the amount of stress relieved by the over coring is obtained using the measured strains. Additional items required include three strain indicators, orientation and placement tools, calibration jig for the BDG, biaxial chamber used to determine Young's modulus of the retrieved core, drilling equipment, and miscellaneous hand tools. The procedures for conducting over coring tests are presented in method RTH 341-80 (U. S. Army Engineer Waterways Experiment Station 1980). Figure 32 illustrates the borehole stress-relief technique.

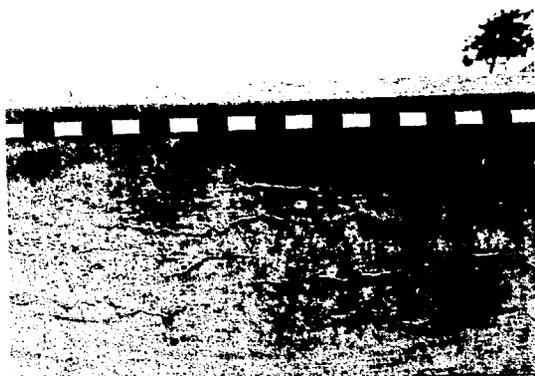
Fig. A.1.1.a—Longitudinal cracks (medium)

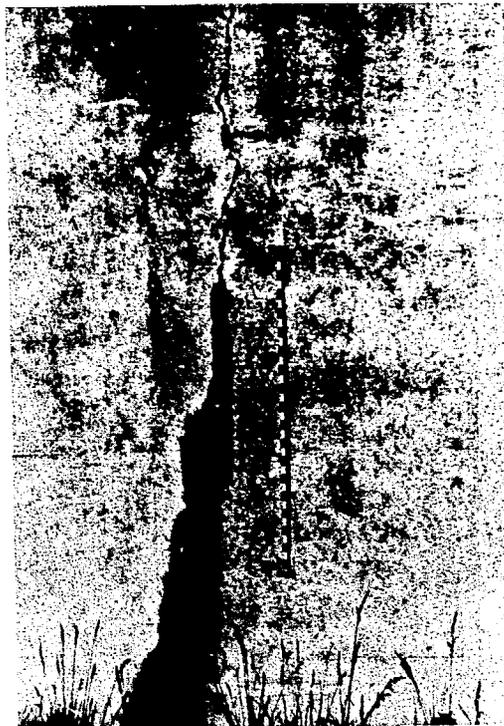
Fig. A.1.1.d—Vertical crack (medium)

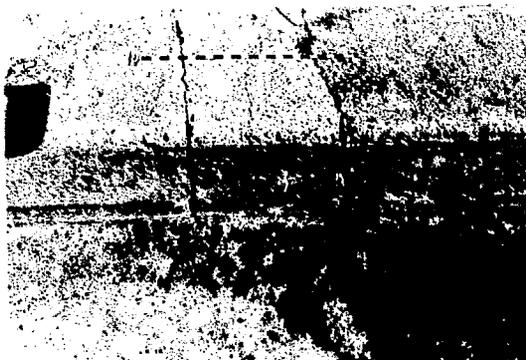
Fig. A.1.1.b—Transverse cracks (wide)

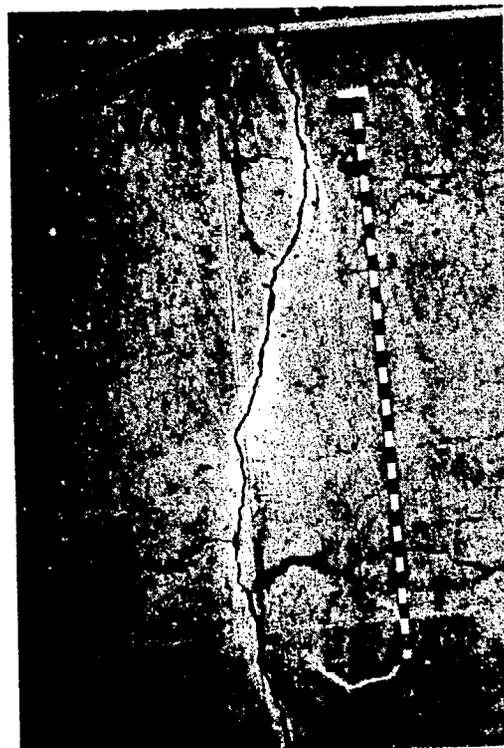
Fig. A.1.1.e—Vertical crack (wide)

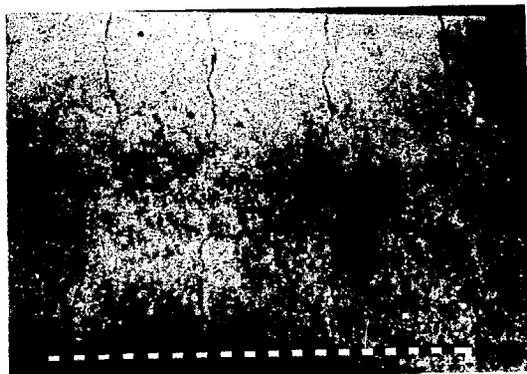
Fig. A.1.1.c—Transverse cracks (fine)

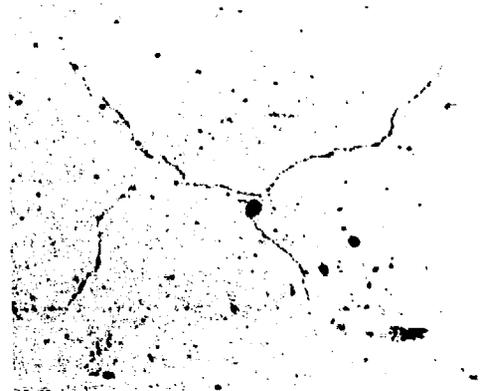
Fig. A.1.1.h—Random cracks (medium)

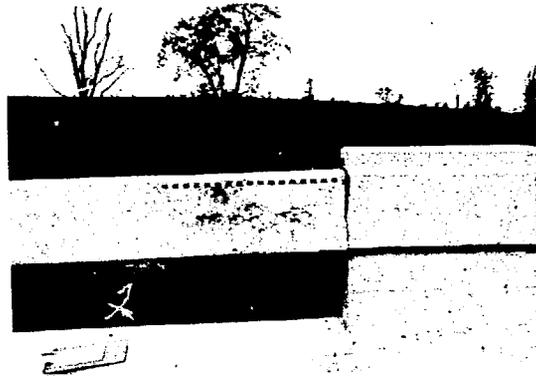
Fig. A.1.5.b—D-cracking (fine)

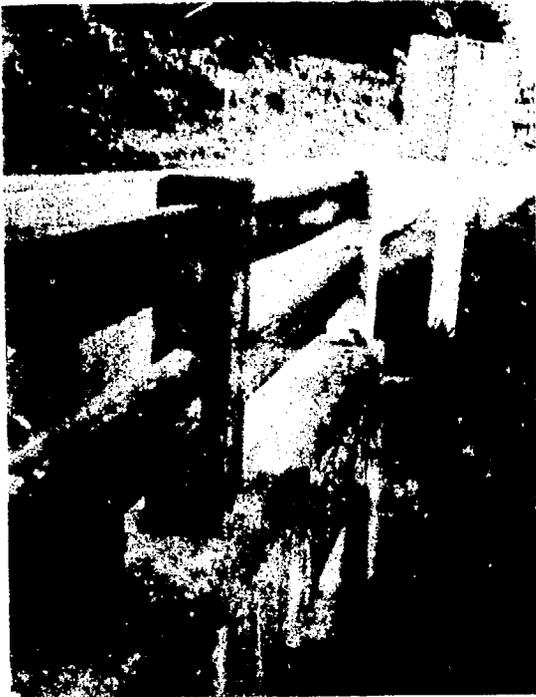
Fig. A.2.2—Distortion

A.2.2. Distortion: Any abnormal deformation of concrete from its original shape (see Fig. A.2.2).

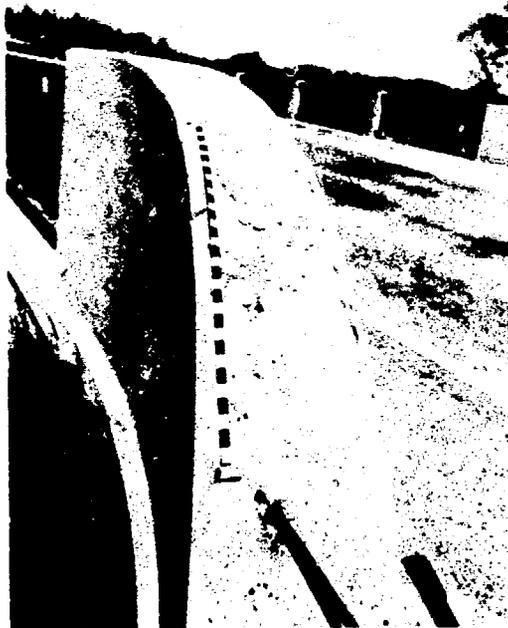
Fig. A.2.9.1.b—Peeling on bridge abutment

A.2.9.1. Peeling: A process in which thin flakes of mortar are broken away from a concrete surface; such as by deterioration or by adherence of surface mortar to forms as forms are removed (see Fig. A.2.9.1.a and A.2.9.1.b).

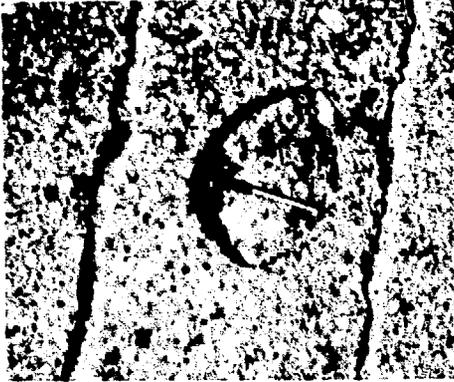
Fig. A.2.10.1—Small spall
